Borrow Source 9.002 Geotechnical Data Report

Mackenzie Valley Highway Project Sahtú Settlement Area, Northwest Territories

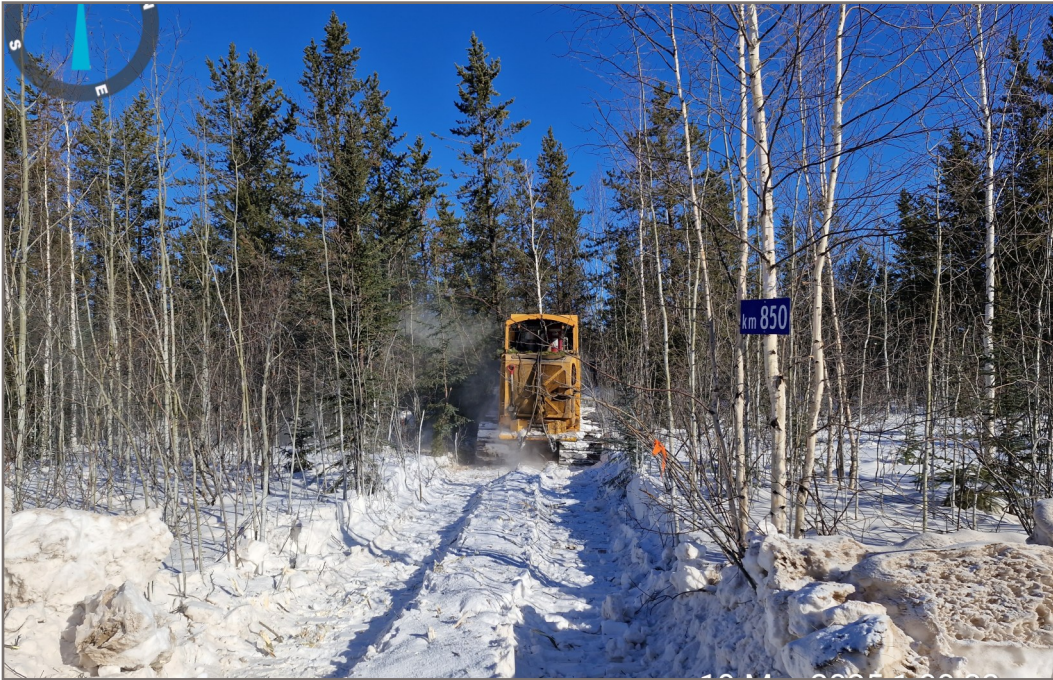
Photo 1: Borrow Source 9.002 (North) Site Access Clearing
Site access clearing in progress near MVWR KM 850
(Photo Date: March 19, 2025)

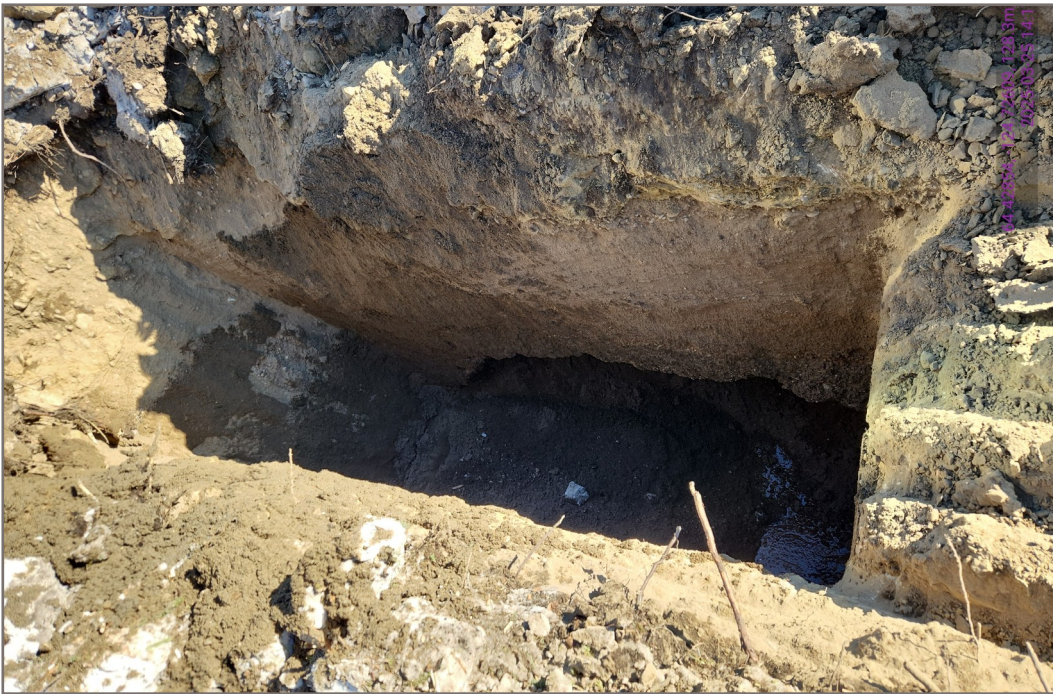
Photo 6: Borrow Source 9.002 (North), Testpit *TP25-9.002-01*
Sand observed in Testpit *TP25-9.002-01*
(Photo Date: March 25, 2025)

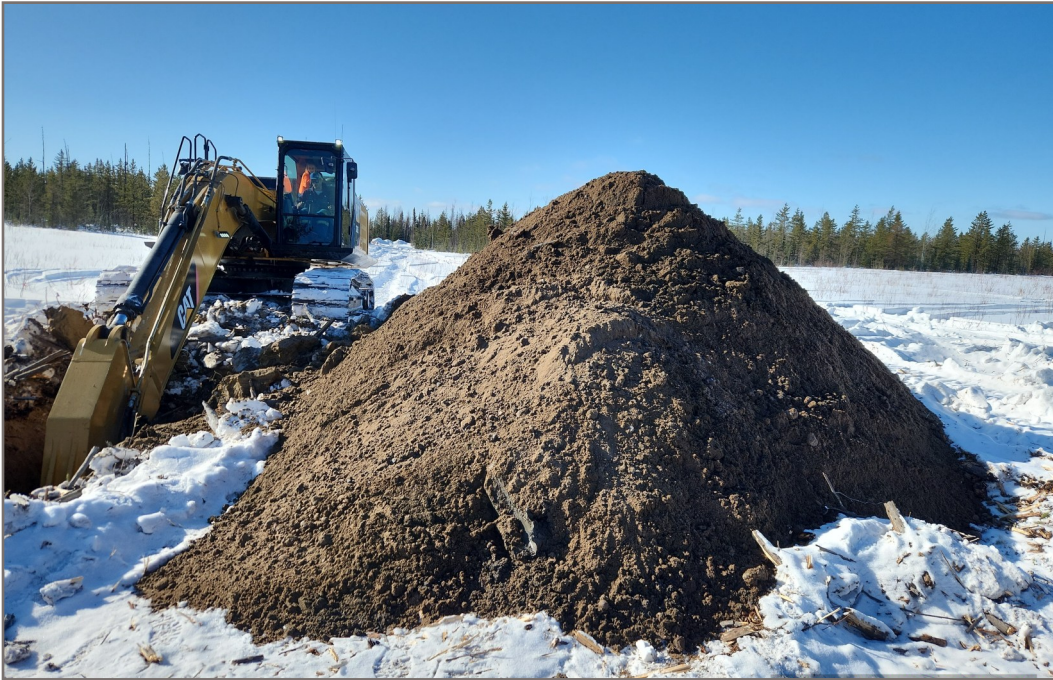
Photo 7: Borrow Source 9.002 (North), Testpit *TP25-9.002-02*
Gravel and Sand excavated from Testpit *TP25-9.002-02*
(Photo Date: March 25, 2025)

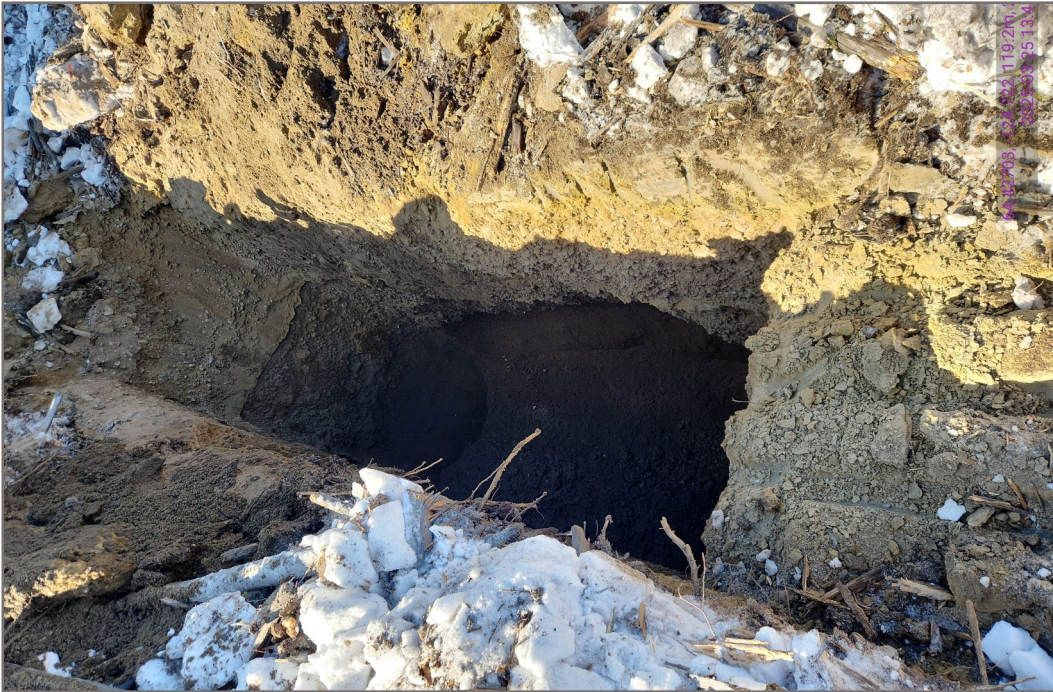
Photo 8: Borrow Source 9.002 (North), Testpit *TP25-9.002-02*
Gravel and Sand observed in Testpit *TP25-9.002-02*
(Photo Date: March 25, 2025)

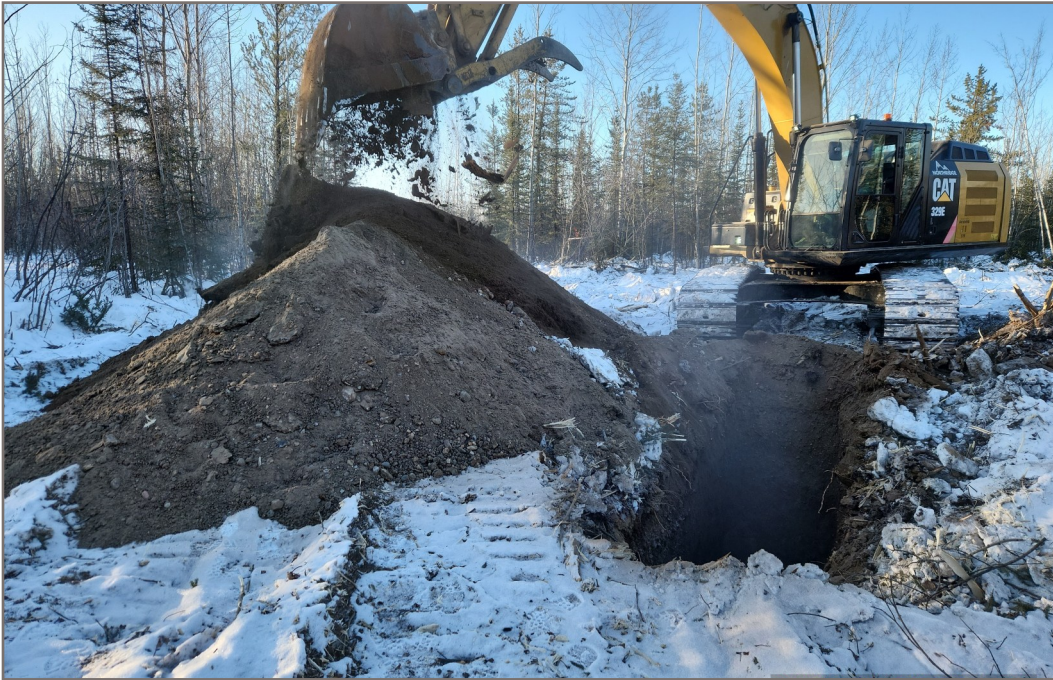
Photo 9: Borrow Source 9.002 (North), Testpit *TP25-9.002-03*
Gravel and Sand excavated from Testpit *TP25-9.002-03*
(Photo Date: March 26, 2025)

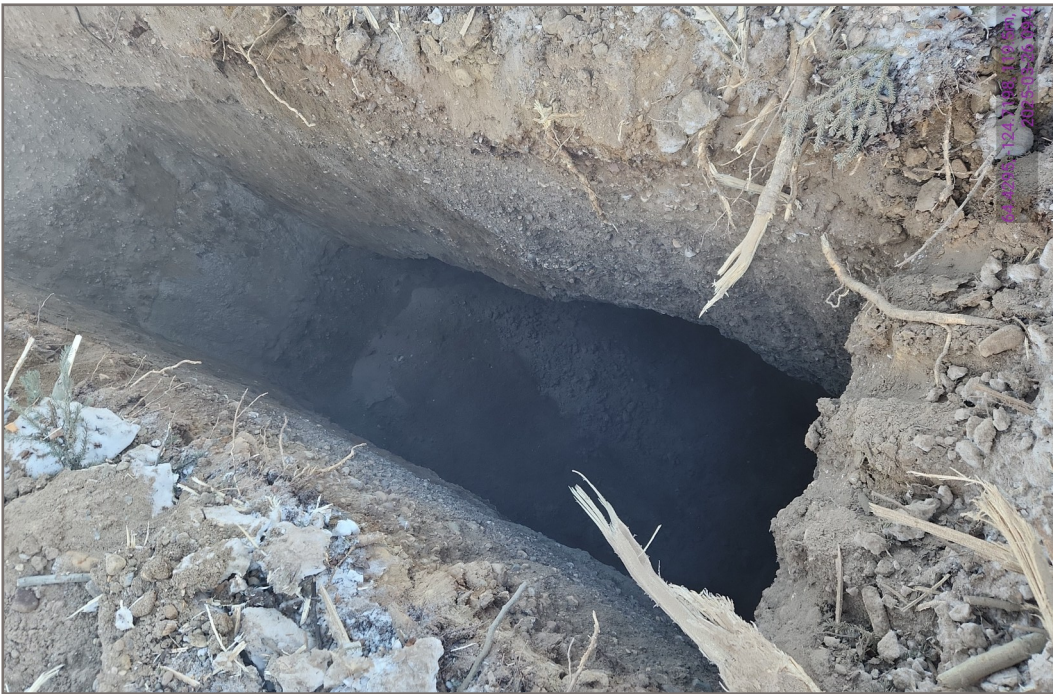
Photo 10: Borrow Source 9.002 (North), Testpit *TP25-9.002-03*
Gravel and Sand observed in Testpit *TP25-9.002-03*
(Photo Date: March 26, 2025)

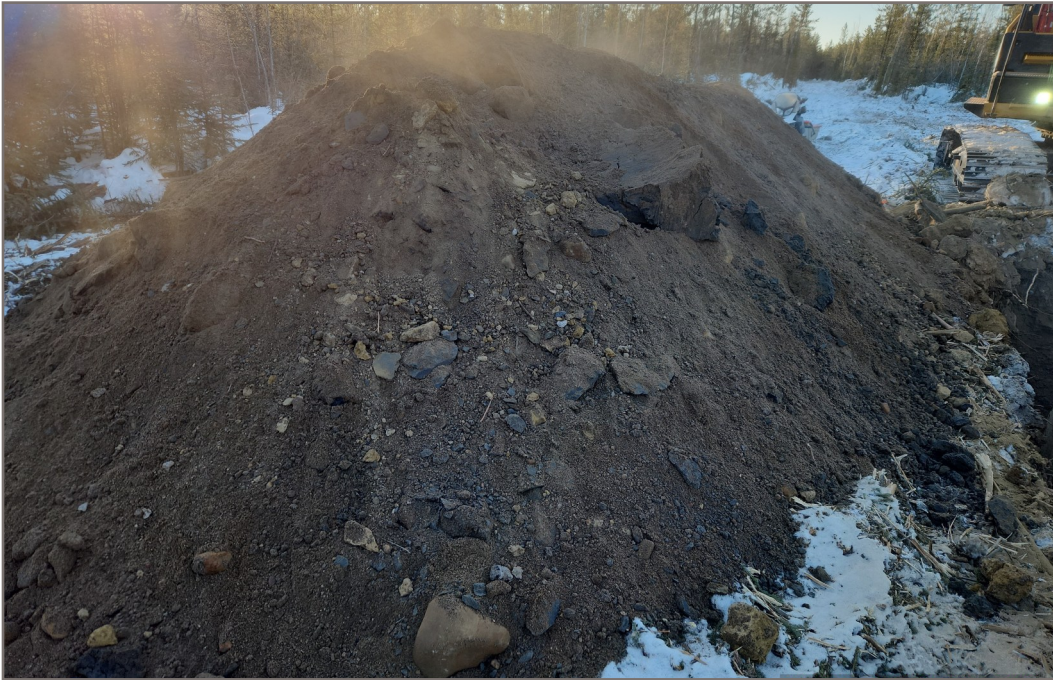
Photo 11: Borrow Source 9.002 (North), Testpit *TP25-9.002-04*
Silt and Sand excavated from Testpit *TP25-9.002-04*
(Photo Date: March 26, 2025)

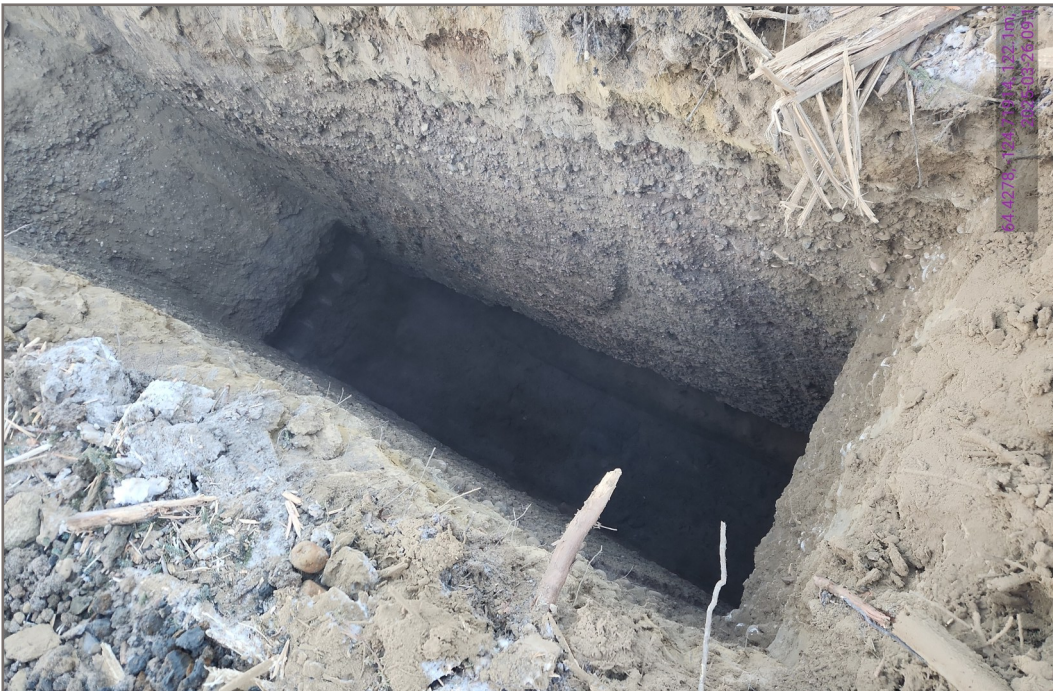
Photo 12: Borrow Source 9.002 (North), Testpit *TP25-9.002-04*
Silt and Sand observed in Testpit *TP25-9.002-04*
(Photo Date: March 26, 2025)

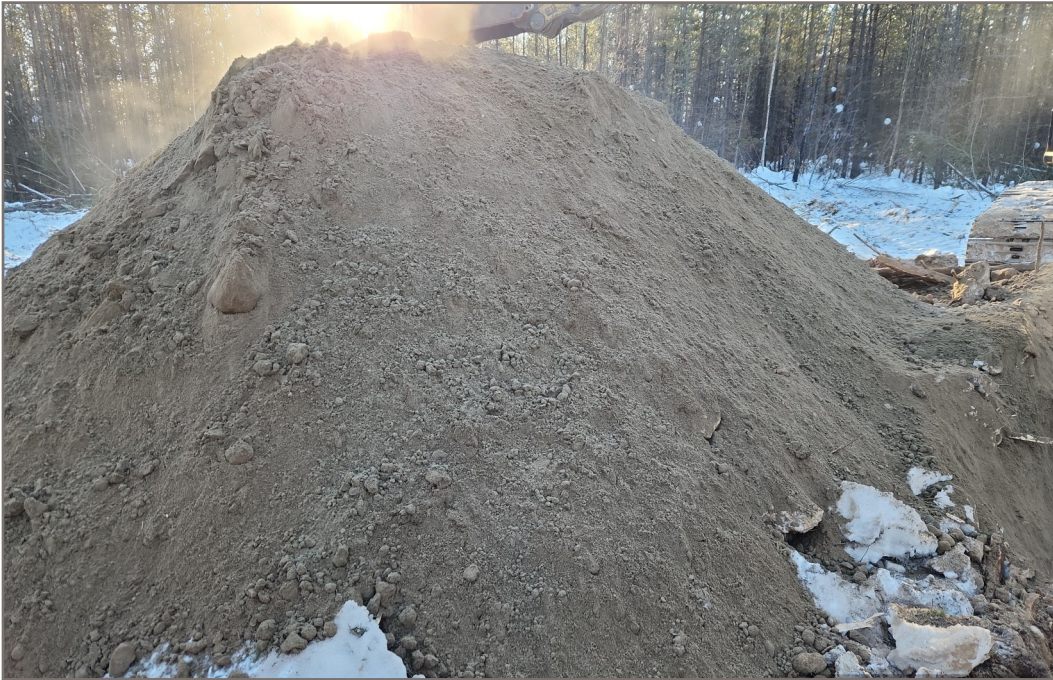
Photo 13: Borrow Source 9.002 (North), Testpit *TP25-9.002-05*
Gravel and Sand excavated from Testpit *TP25-9.002-05*
(Photo Date: March 26, 2025)

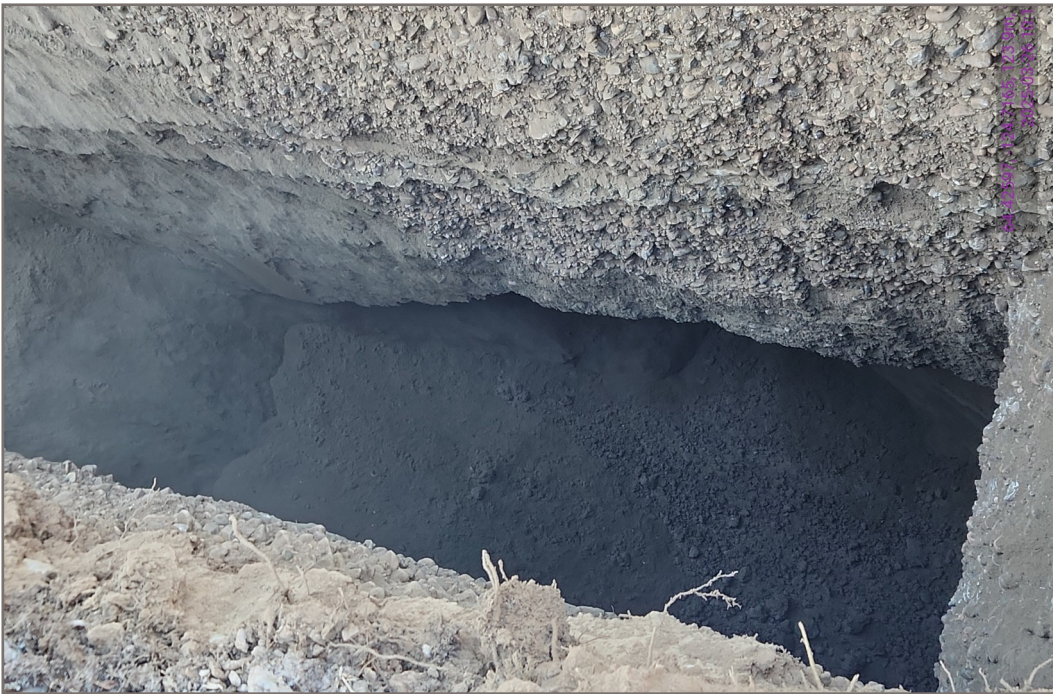
Photo 14: Borrow Source 9.002 (North), Testpit *TP25-9.002-05*
Gravel and Sand observed in Testpit *TP25-9.002-05*
(Photo Date: March 26, 2025)

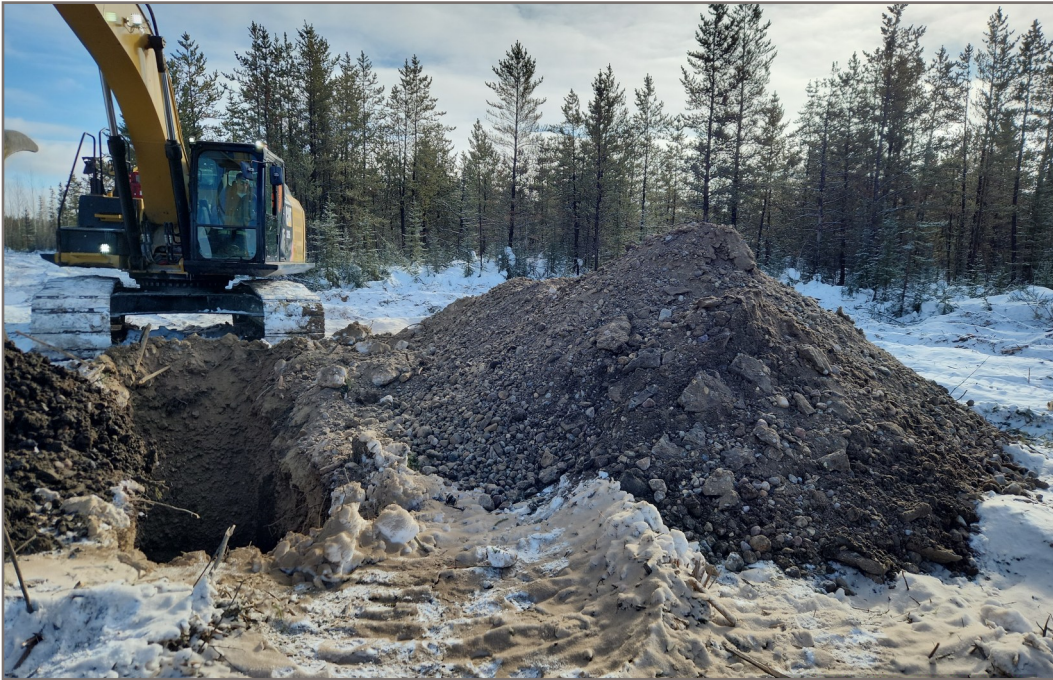
Photo 15: Borrow Source 9.002 (South), Testpit TP25-9.002-06
Gravel and Sand excavated from Testpit TP25-9.002-06
(Photo Date: March 25, 2025)

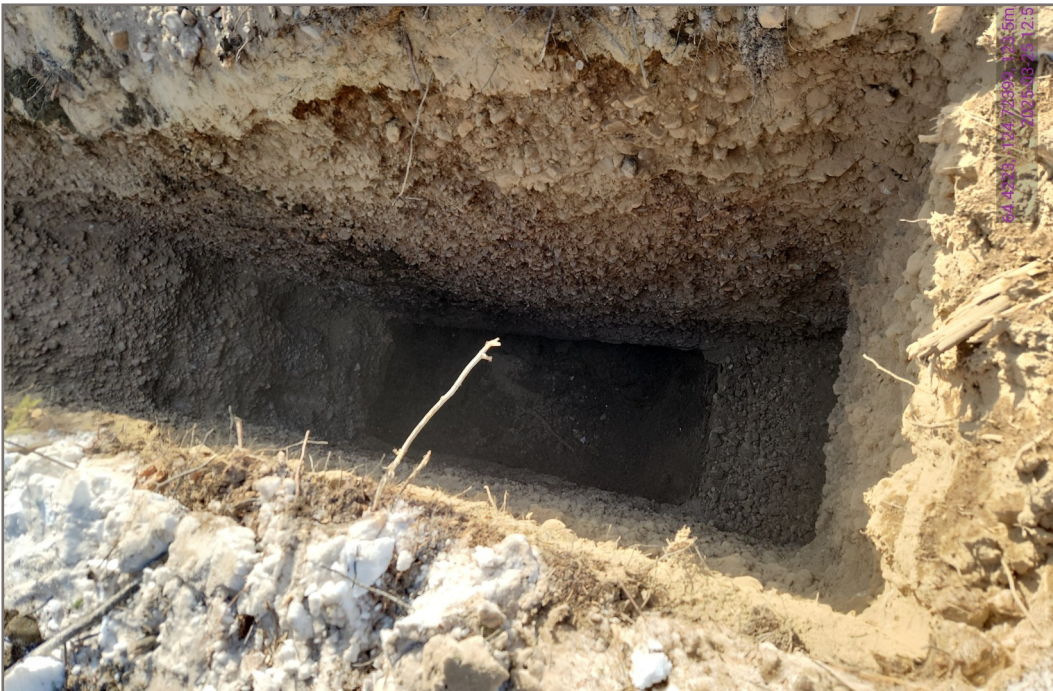
Photo 16: Borrow Source 9.002 (South), Testpit TP25-9.002-06
Gravel and Sand observed in Testpit TP25-9.002-06
(Photo Date: March 25, 2025)

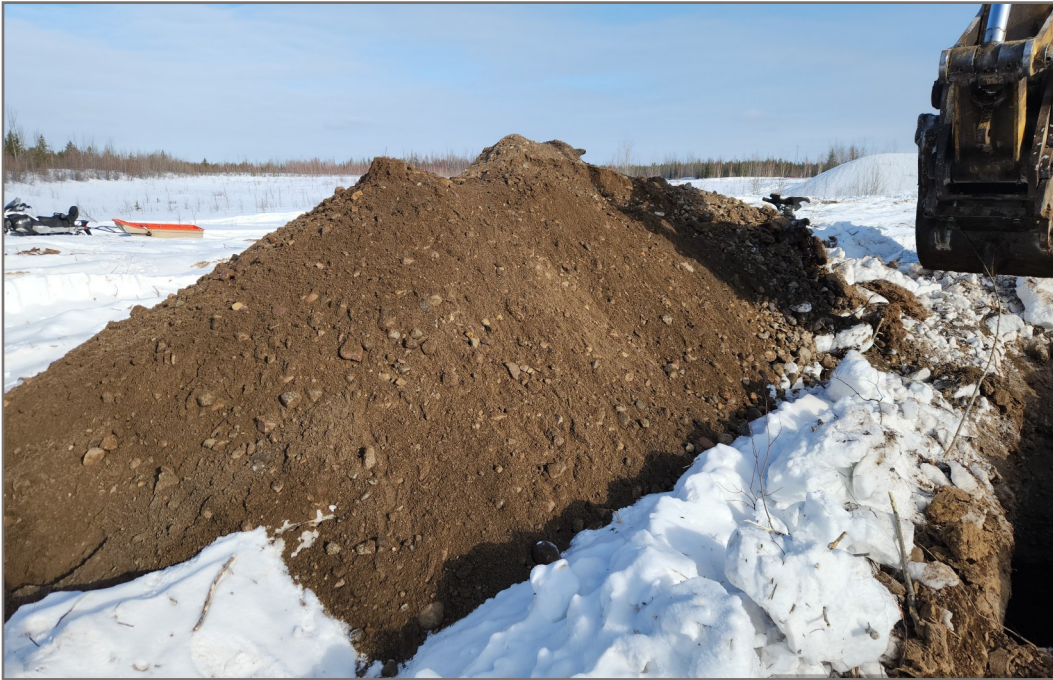
Photo 17: Borrow Source 9.002 (South), Testpit TP25-9.002-07
Gravel and Sand excavated from Testpit TP25-9.002-07
(Photo Date: March 25, 2025)

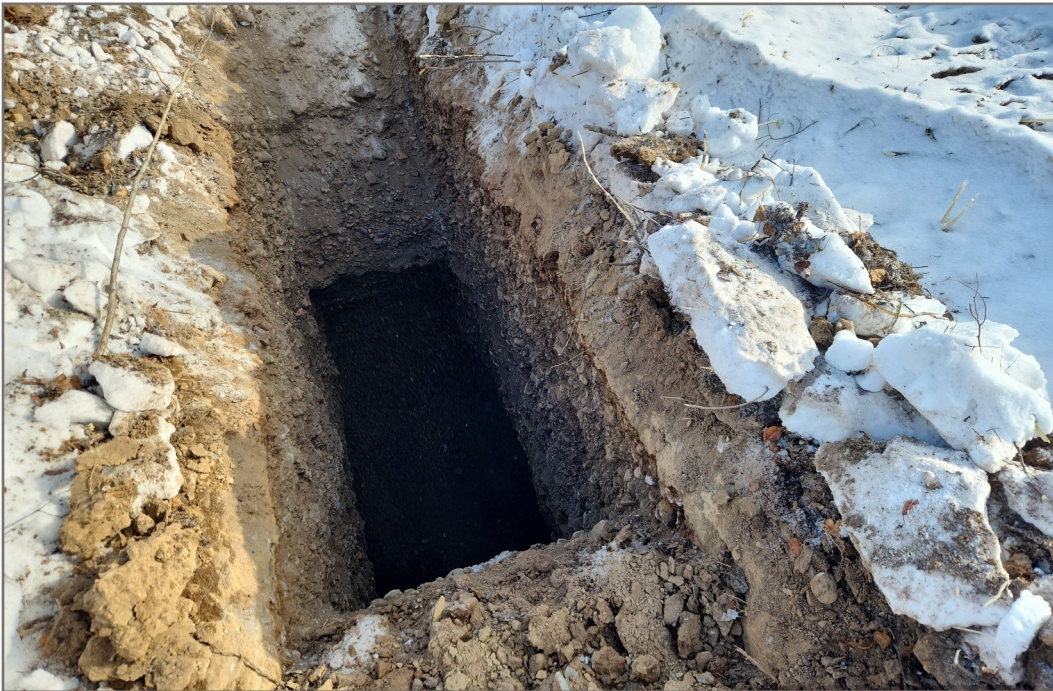
Photo 18: Borrow Source 9.002 (South), Testpit TP25-9.002-07
Gravel and Sand observed in Testpit TP25-9.002-07
(Photo Date: March 25, 2025)

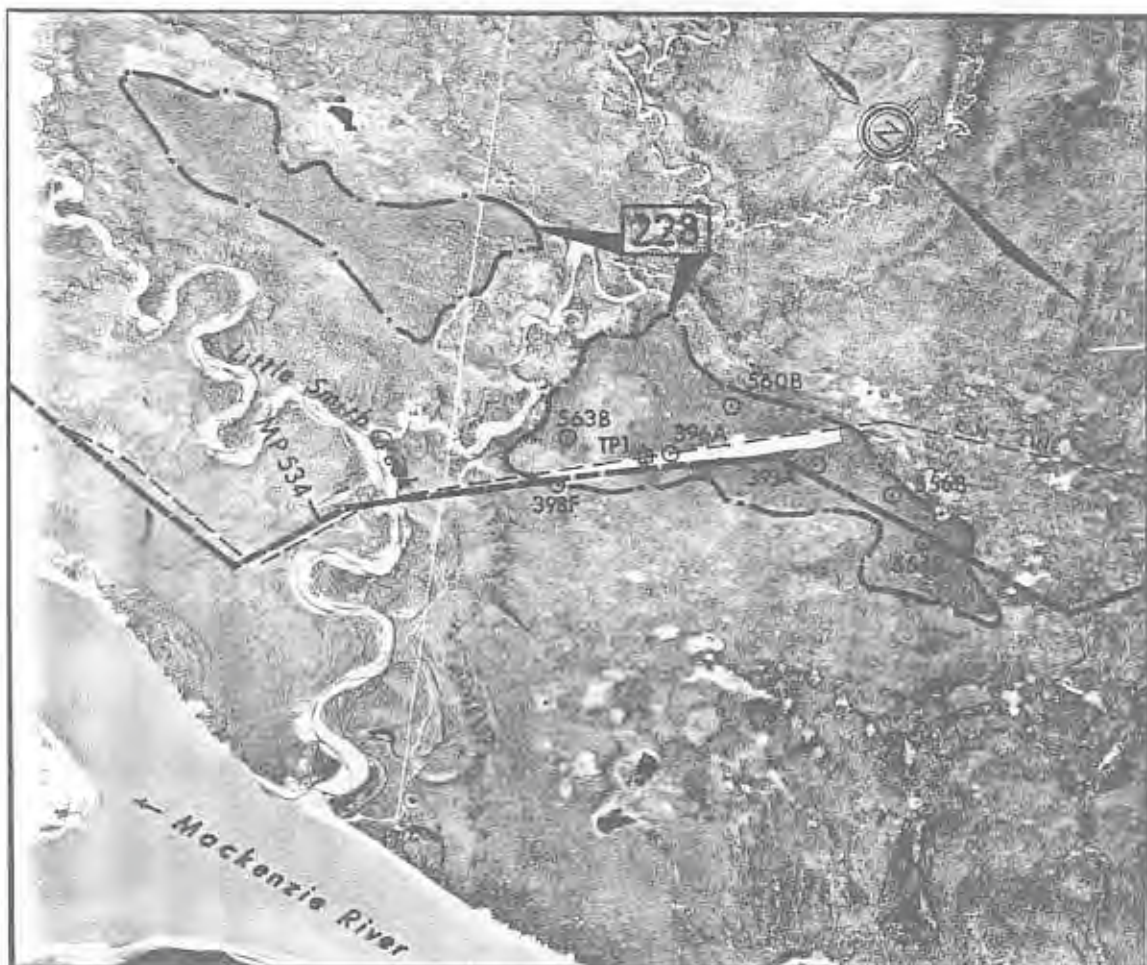
Assessment: Good quality material suitable in the pit run condition as general fill for the construction of road bases and utility backfill. Site 228 is recommended for development.

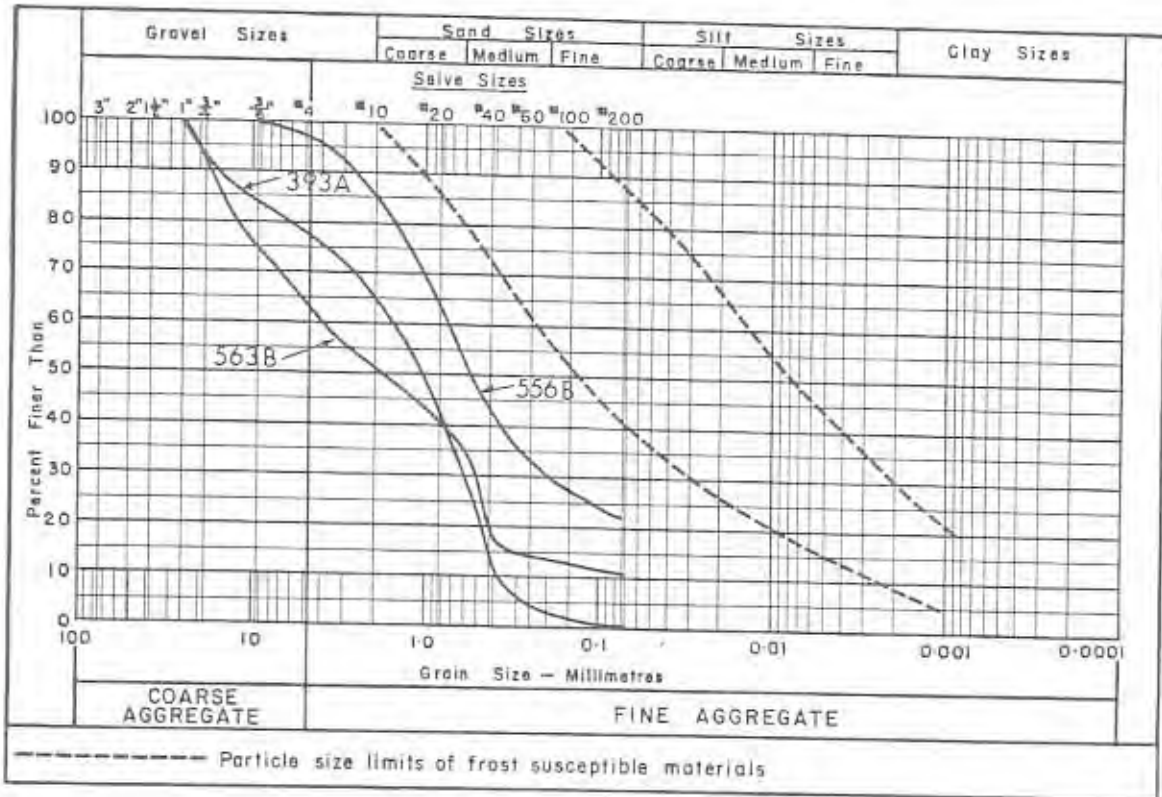
PETROGRAPHIC ANALYSIS:

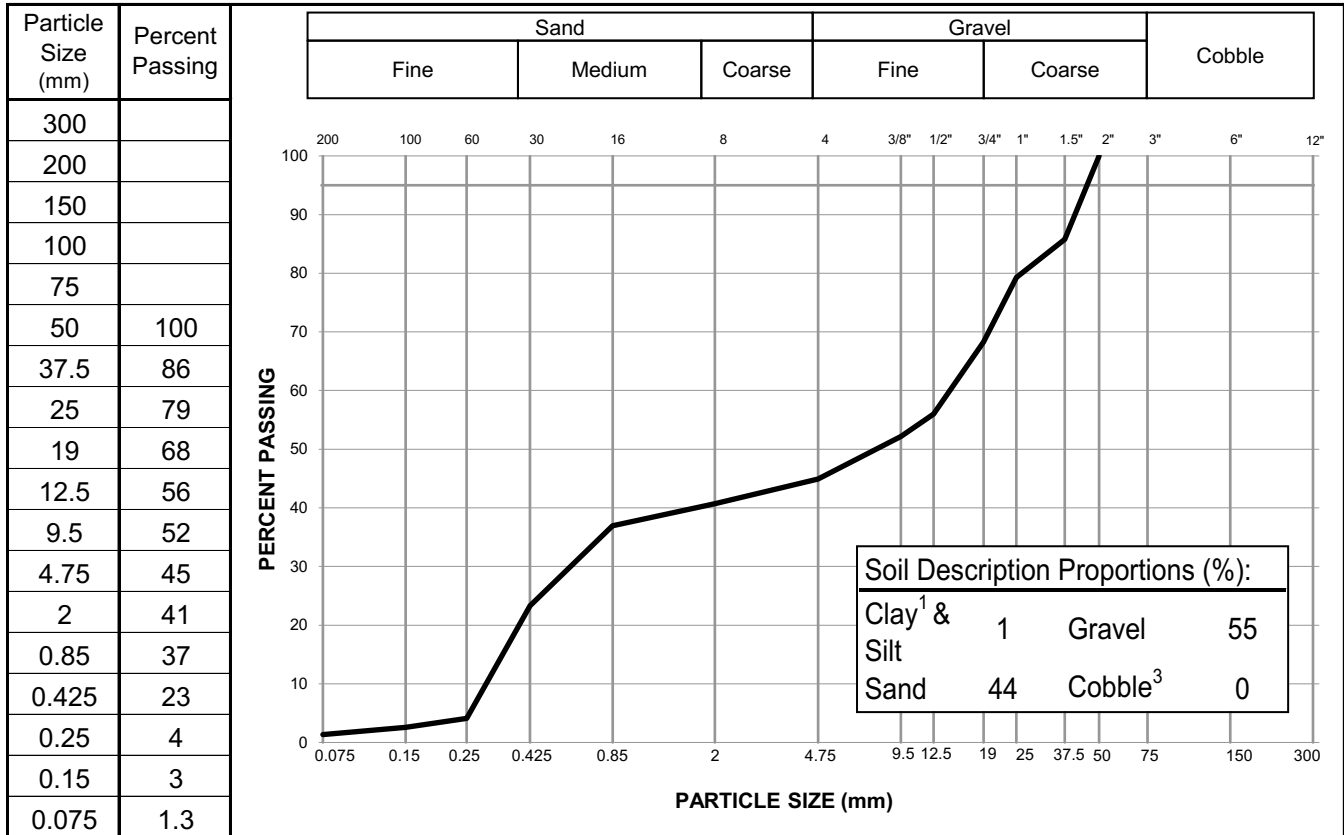
Notes: ¹ The upper clay size of 2 um, per the Canadian Foundation Engineering Manual
² The description is visually based & subject to Tt WM4400 description protocols
³ If cobbles are present, sampling procedure may not meet ASTM C702 & D75

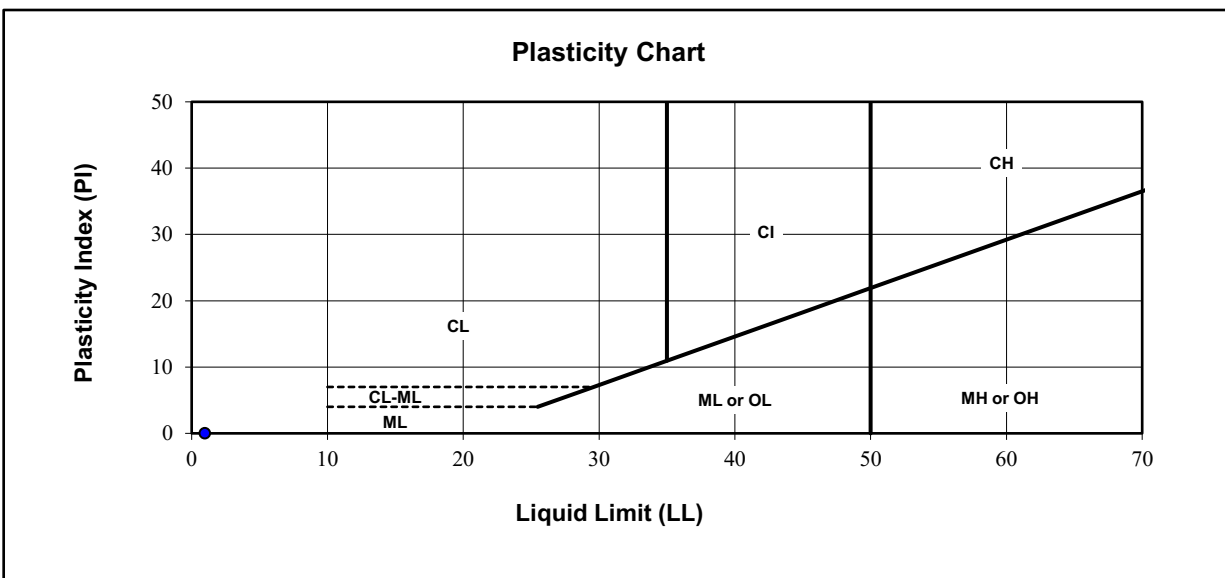
Liquid Limit (LL) : N/A

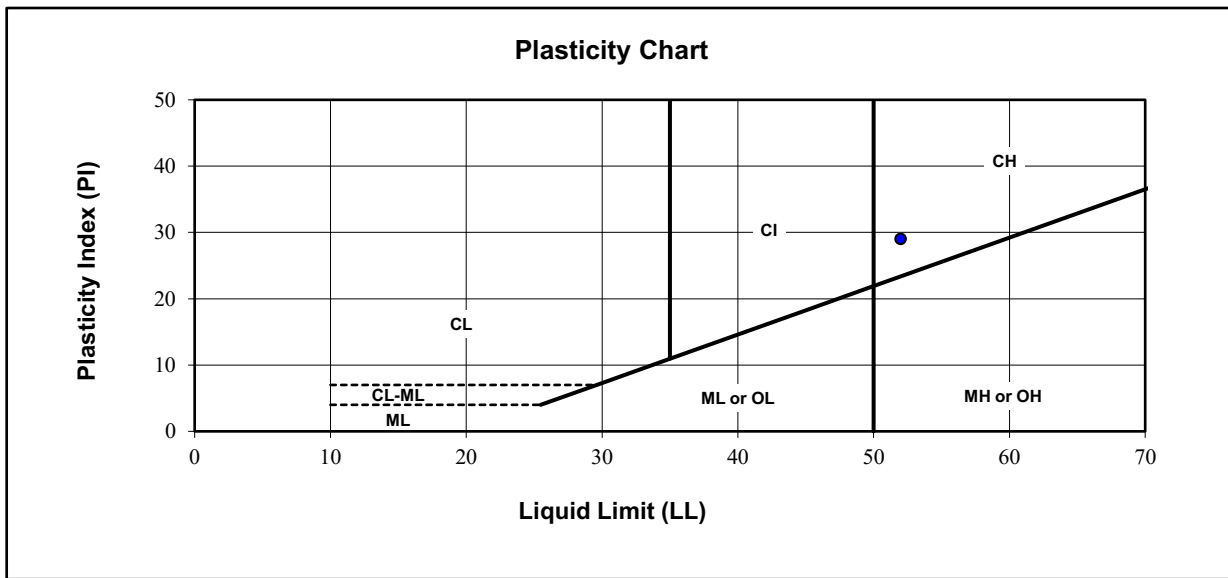
Liquid Limit (LL) : 52

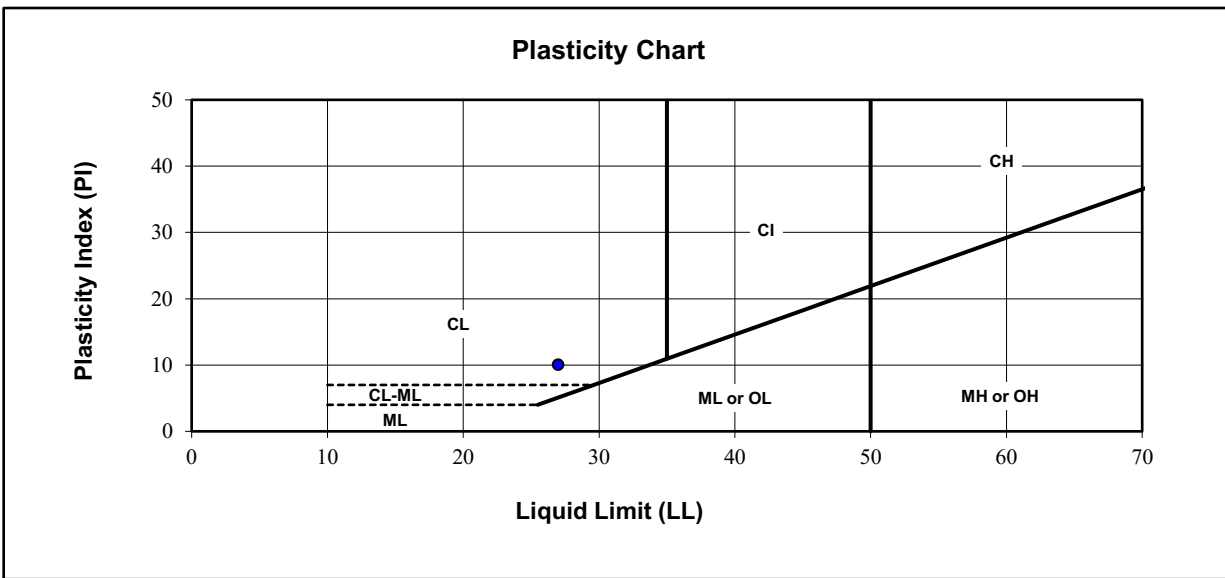
Liquid Limit (LL) : 27

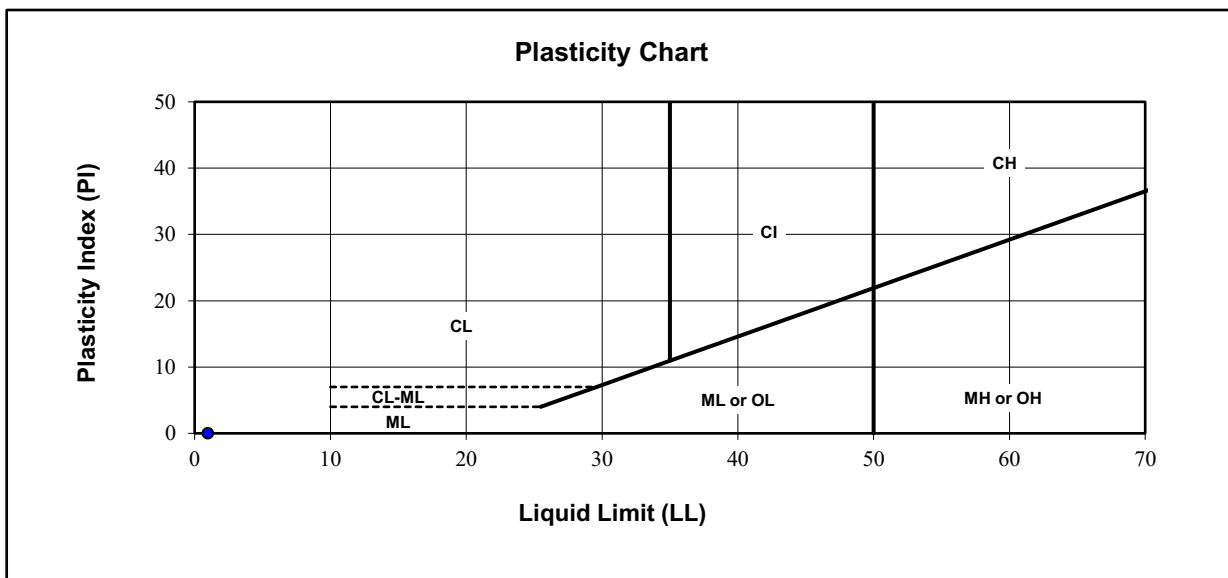
Liquid Limit (LL) : N/A
