TETRA TECH

Mackenzie Valley Highway Sahtu South Segment Hydrotechnical Assessments GNWT Service Contract SC-5132

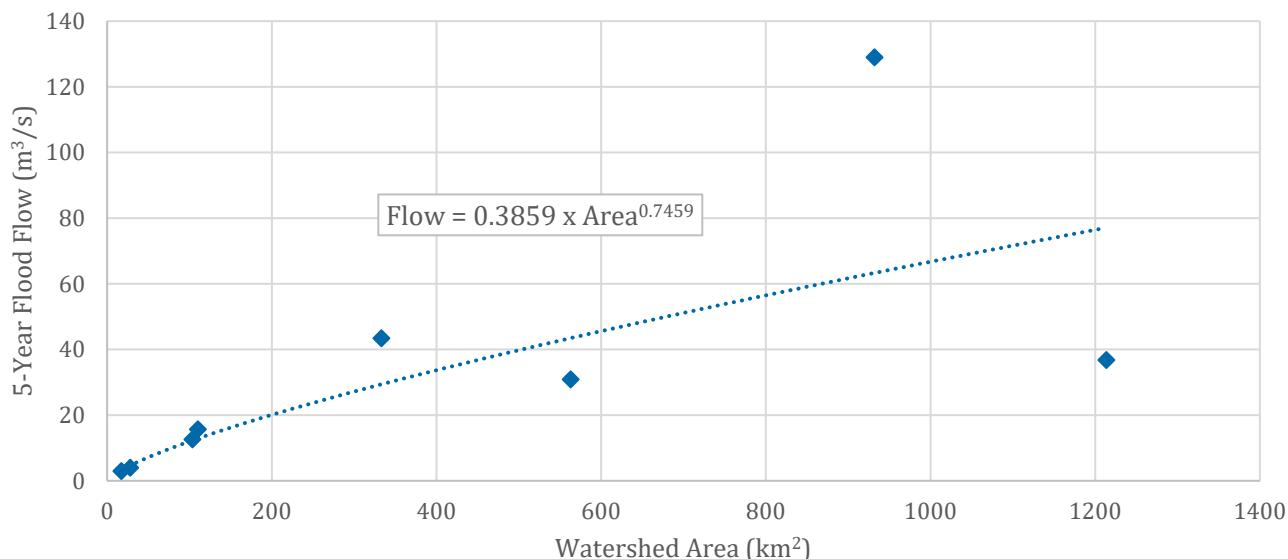
Figure 4-4: 5-Year Peak Flow versus Watershed Area for Regional WSC Stations

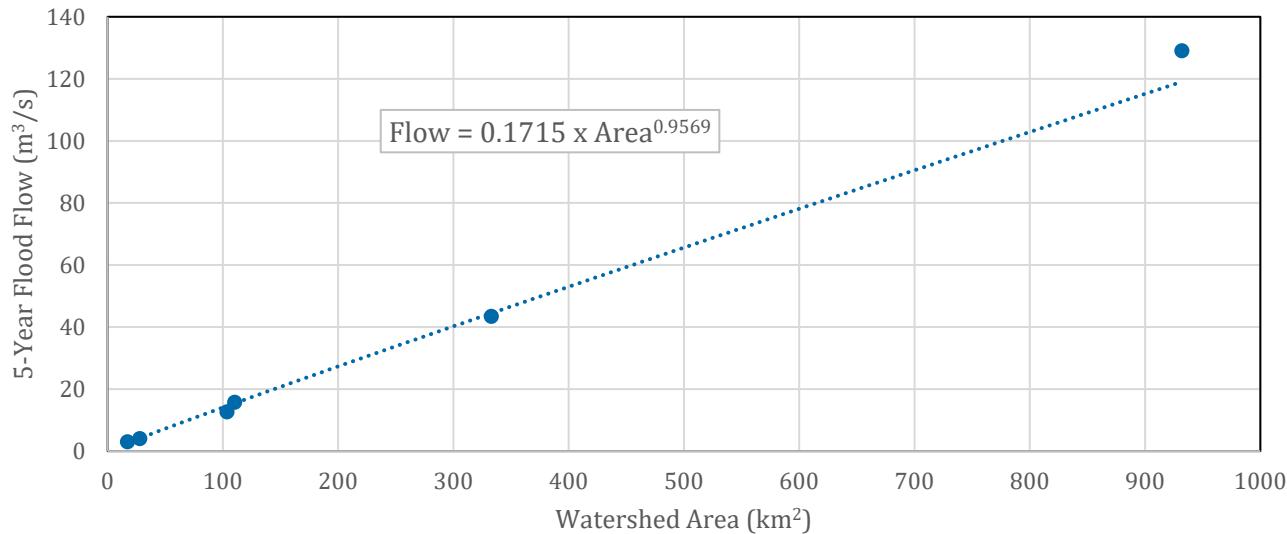
Figure 4-5: 5-Year Flow vs Watershed Area for WSC Stations < 5% Lake Area

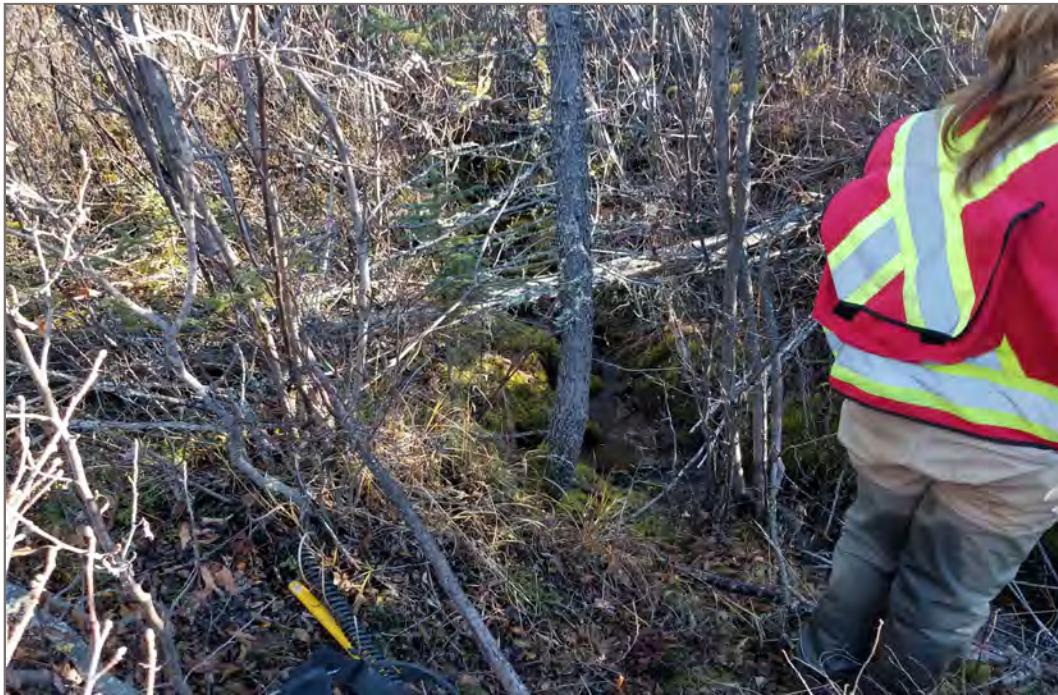
Photo 7: KM 812.7 (1 of 5) - Looking north (upstream) at PDR alignment. Channel is small at this location with only 2 L/s of flow observed.

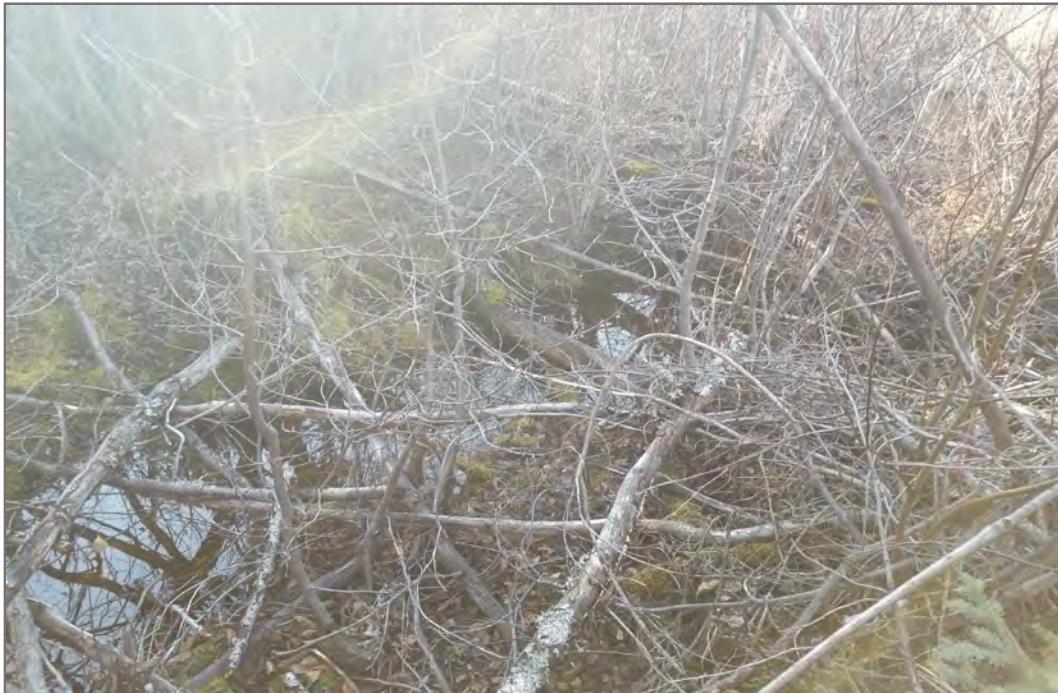
Photo 8: KM 812.7 (2 of 5) – Looking southeast (downstream) at PDR alignment.

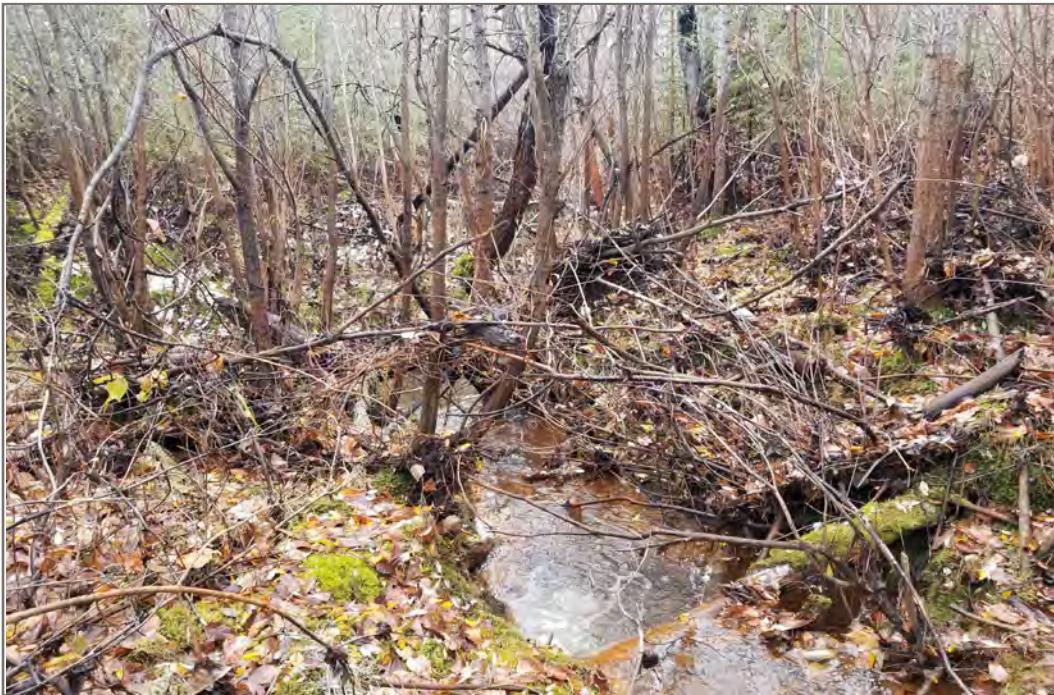
Photo 85: KM 884.8 (4 of 5) – Looking west (downstream) at PDR alignment. Staining on trees indicates area was previously flooded by beaver dams ~2m higher than current water level.

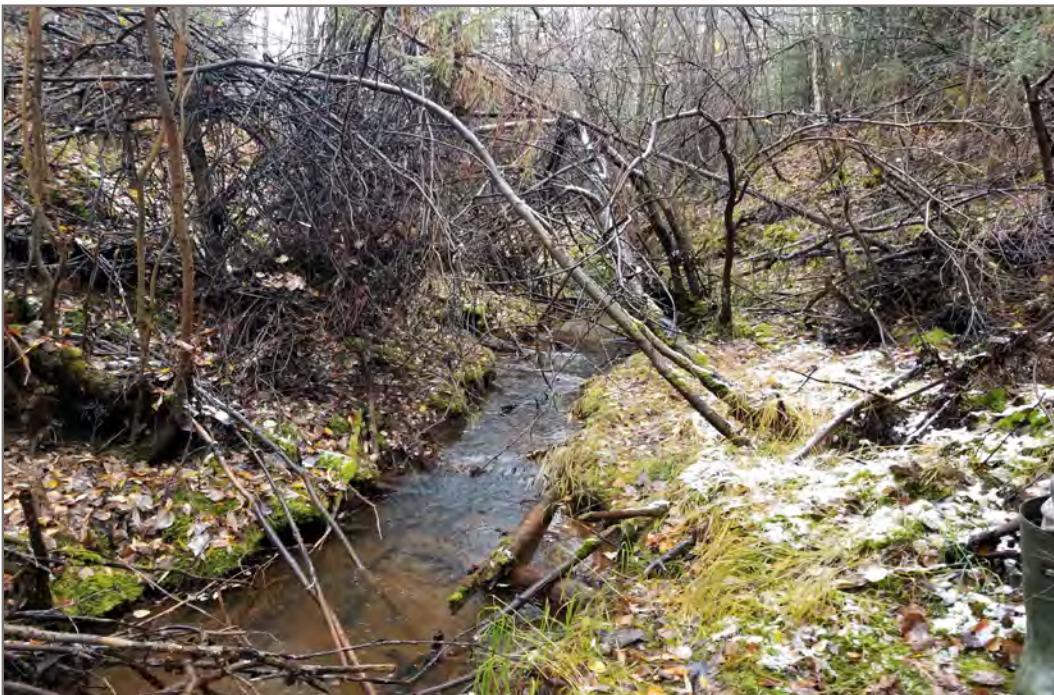
Photo 86: KM 884.8 (5 of 5) – Looking west (downstream) approximately 200m downstream of PDR alignment. 12 L/s in defined 1m x 0.3m deep channel.
