**Inuvik to Tuktoyaktuk Highway -
Baseline Data Acquisition Program
Terrain Evaluation**

Final Report

Prepared for:
**Government of the Northwest
Territories – Department of
Transportation**
Yellowknife, NT

Prepared by:
KAVIK-STANTEC INC.

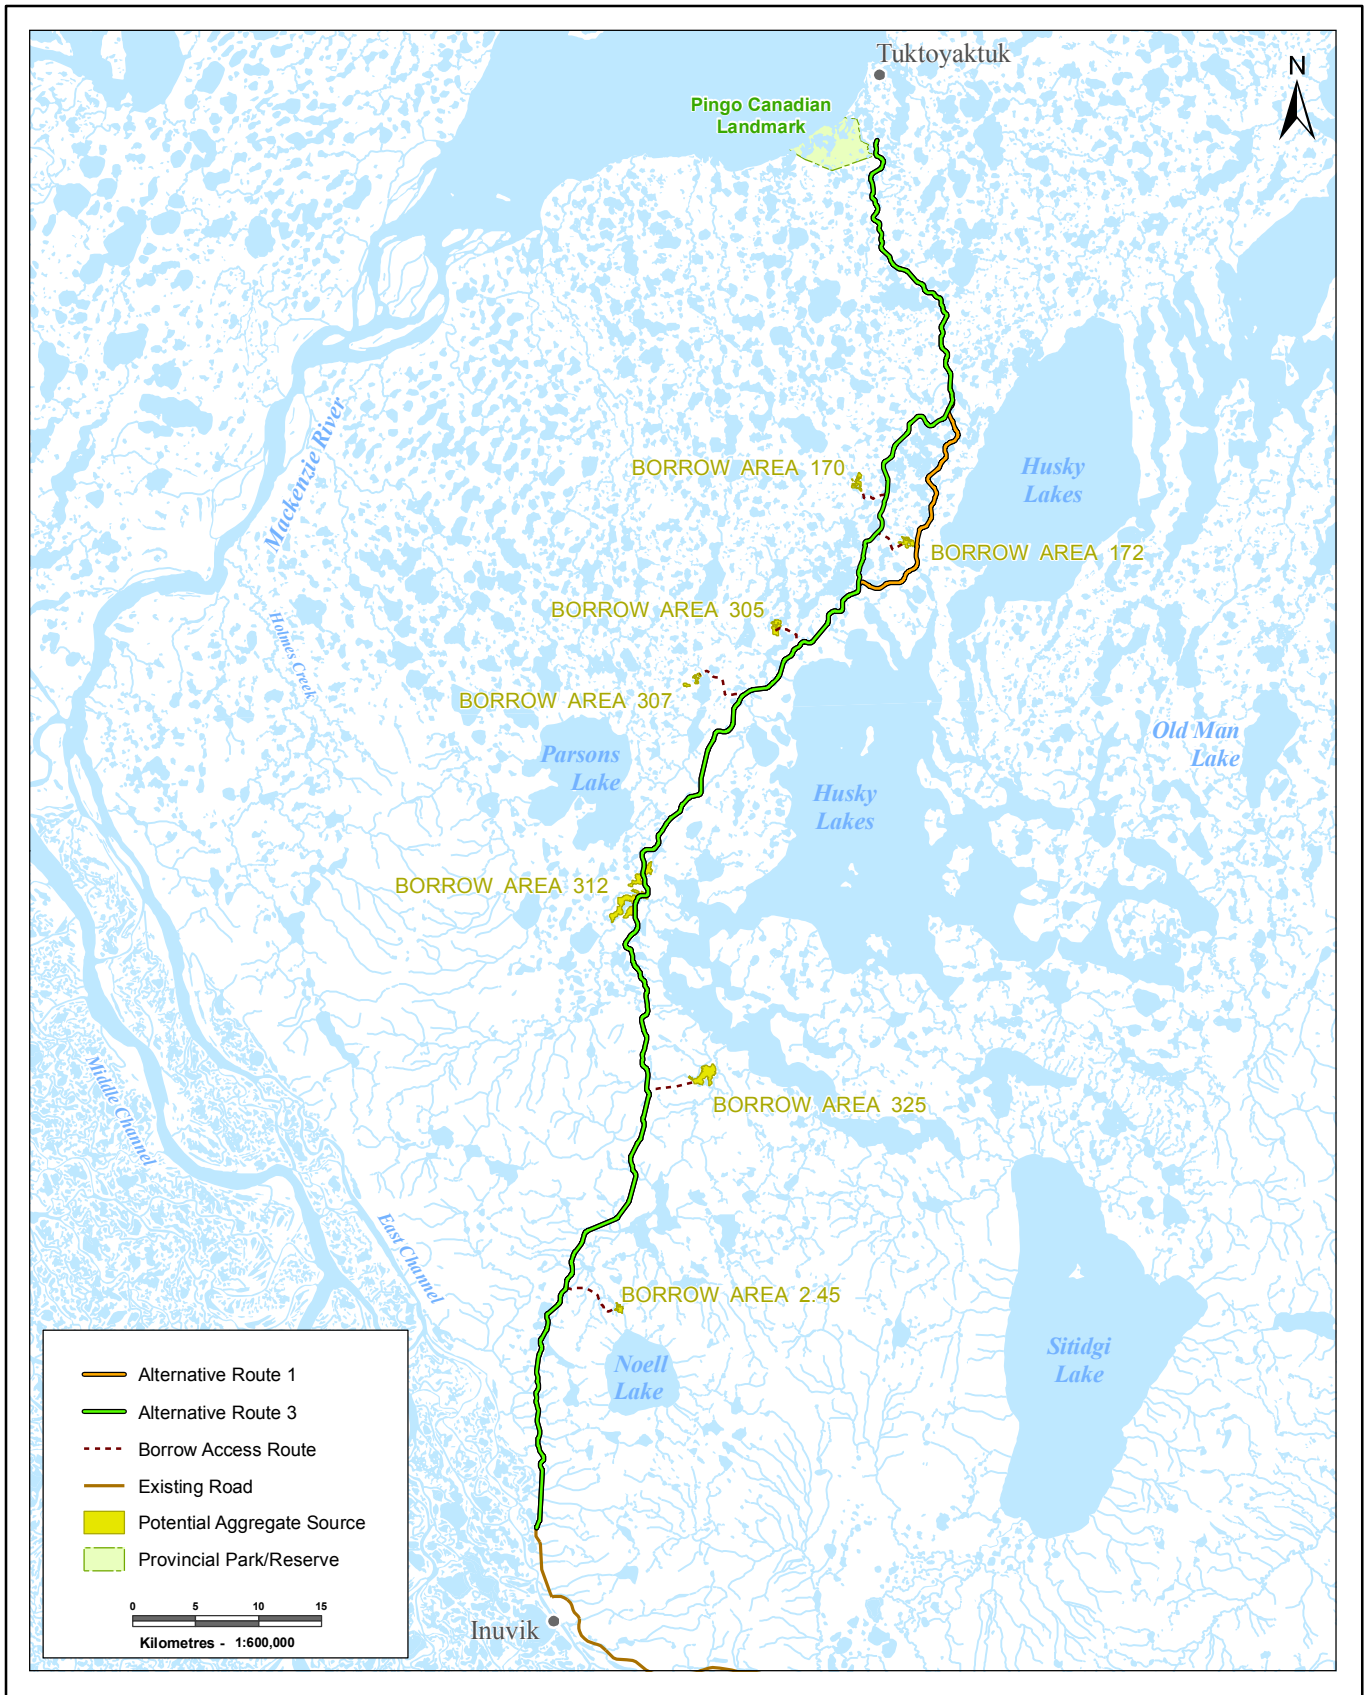
Inuvik – Tuktoyaktuk Highway, Baseline Data Acquisition Program

Proposed Highway Alignments, Borrow Sources and Access Roads

- **Alternative 1** – The 2009 Minor Realignment of the Primary 2009 Route to fully achieve the Husky Lakes 1 km setback requirements; and
- **Alternative 3** – the 2010 Minor Realignment, recommended by Inuvialuit interests to modify Alternative 1 and to provide a more direct route.

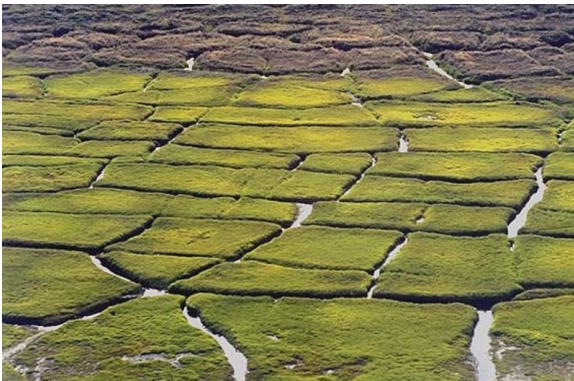
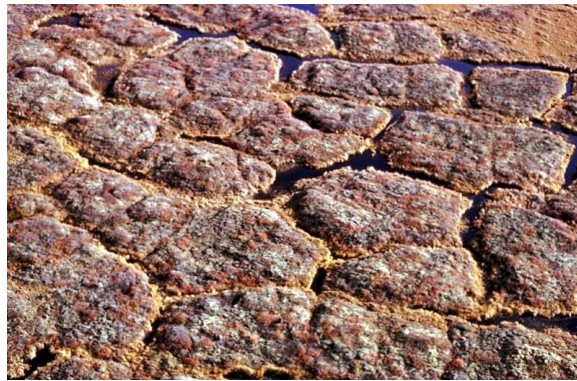
Figure 3-2 Low-centered polygons and high-centered polygons (photos from Geological Survey of Canada)

Ice wedge polygons are a type of patterned ground that is found primarily in low-lying, moderate to poorly-drained areas. They are the result of thermal contraction and cracking of the ground surface which then forms a random or oriented polygonal pattern (ACGR 1988). The cracks that result from the thermal cracking fill with seepage water that comes primarily from the melting of snow and the water refreezes during winter as ice veins. As frost cracking reoccurs in pre-existing cracks, the accretion of ice veins with time builds up ice wedges (Fortier and Allard 2004). The volume of ice contained in tundra polygons is extensive and probably represents the most widespread and abundant form of ground ice (Washburn 1979; Harry and Gotzik 1988; Kasper and Allard 2001). Ice-wedge polygons occur in both mineral terrain and peatlands. They can be classified as low-centered and high-centered (Figure 3-2 as well as photo A-3 and A-4 of Appendix A); the contrast between the two types may be partially due to the age of the features as well as the local hydrology (Rampton 1988). Over time, low-centered polygons can evolve into high-centered polygons.

Polygons found along the alignment range considerably in size but are typically 15 to 30 m in width. They are found extensively throughout the project, but especially in low-lying areas such as peatlands, drained lake bottoms and former meltwater channels. Both proposed alignments cross several large polygonal peatlands characterized by poor drainage.

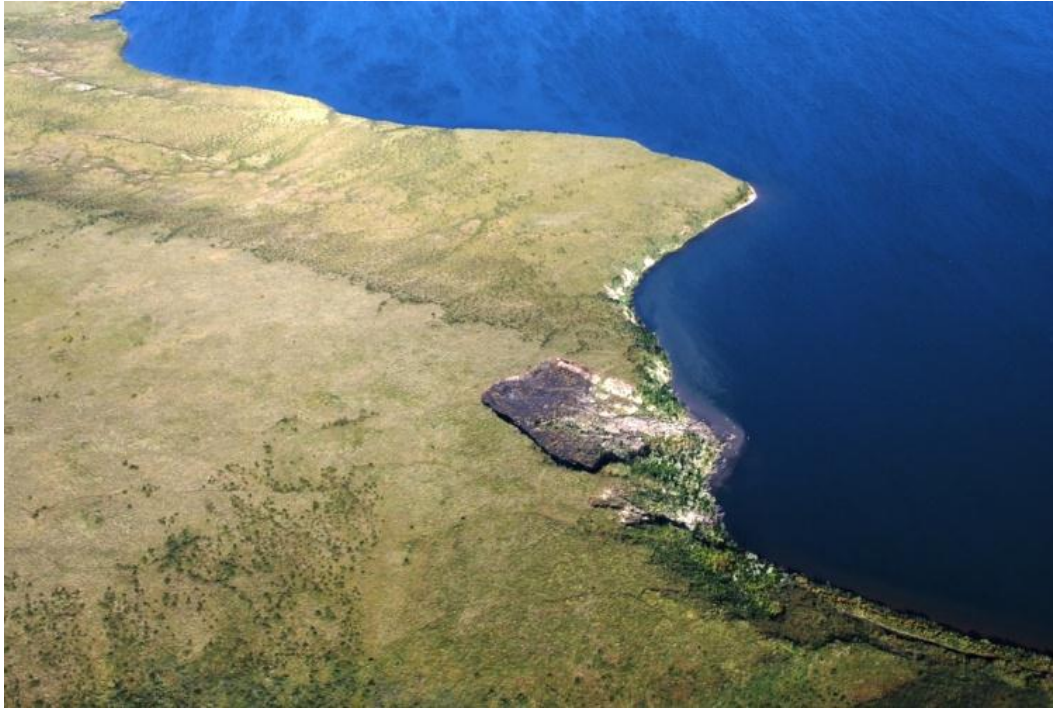
Photo A-1 Retrogressive thaw slumps near KP 93 of Alternative 1

The vast majority of the retrogressive thaw slumps found within the project area are located along the shoreline of small lakes, many of which are of thermokarst origin (photos A-1 and A-2). The parent material in which they form is mostly fine grained till and lacustrine materials. The slumps vary widely in form and size, but on average are 75 to 150 m wide. Many of the slump units are composed of the coalescence of smaller slides. The presence of vegetation on some of the slumps indicates that they are [somewhat] stable; however the reactivation of older slump units was observed (by air photo-interpretation) at several locations.

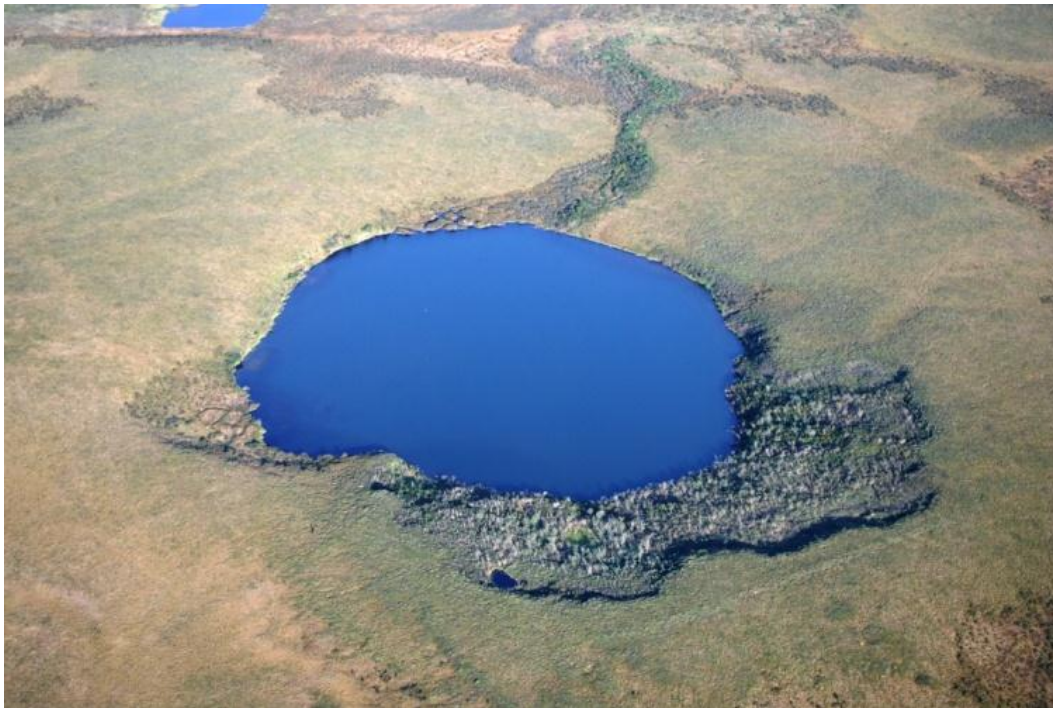
Photo A-2 Retrogressive thaw slumps west of KP 50

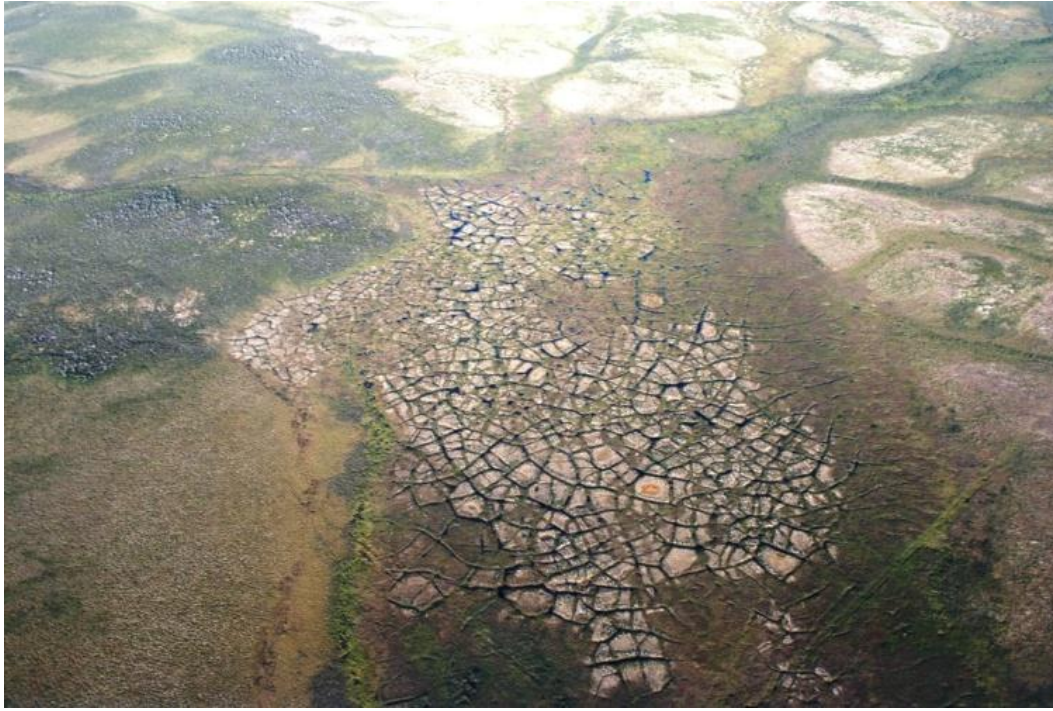
Photo A-3 Low center polygon near Borrow Source 2.45

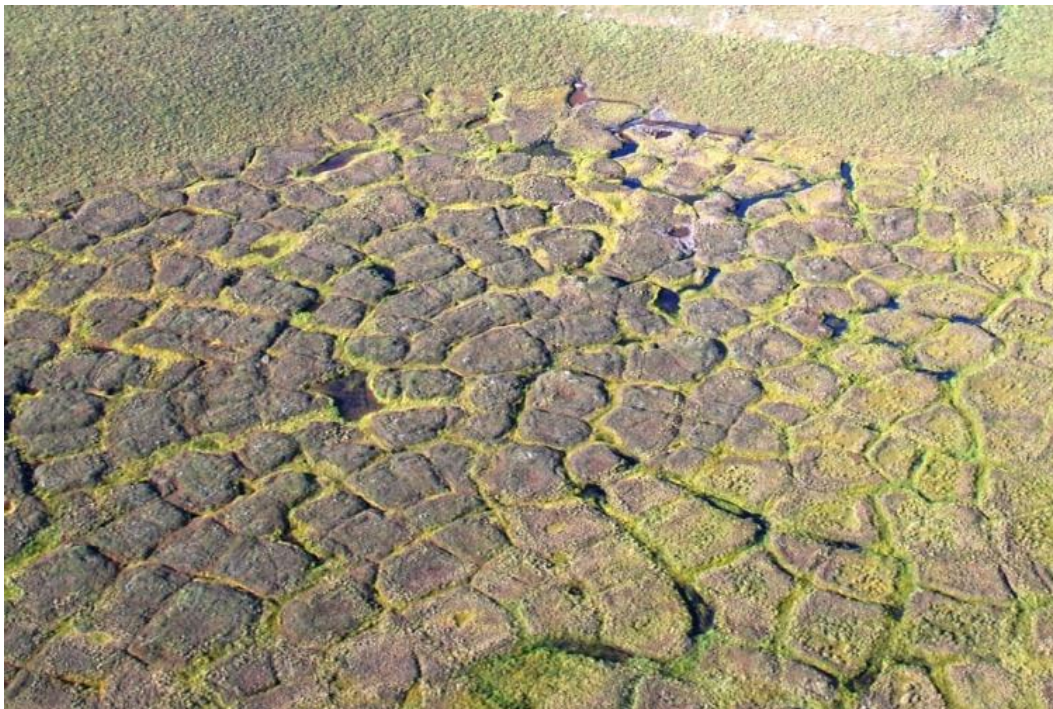
Photo A-4 High center polygon near KP 66

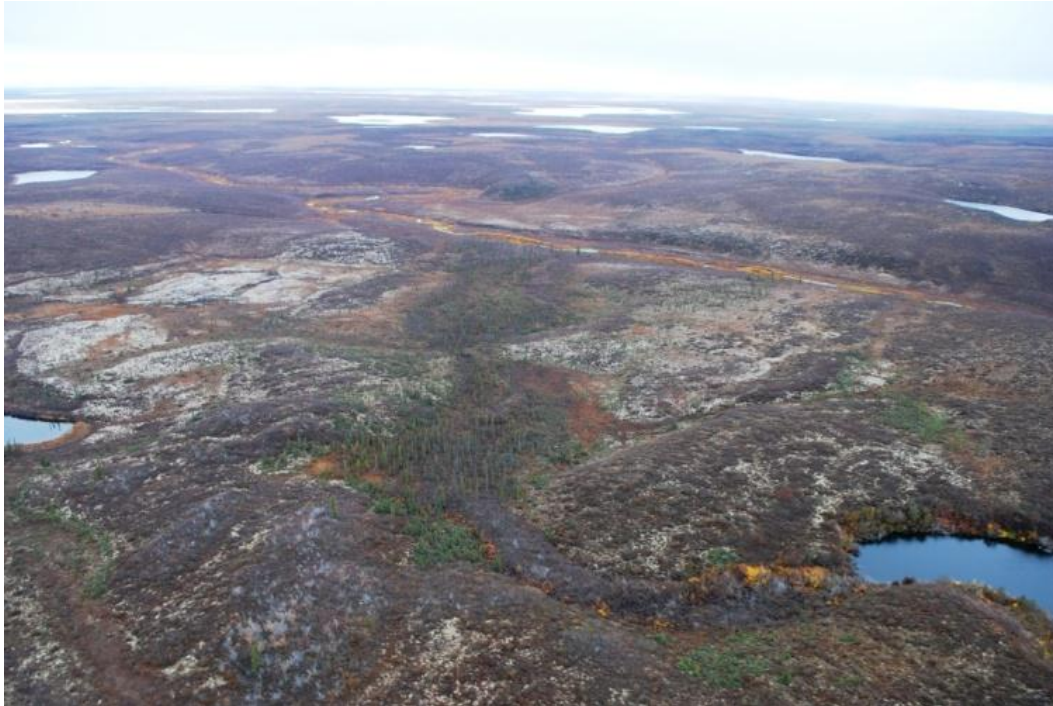
Photo A-5 Aerial oblique view of Borrow Source 2.45 (looking northeast)

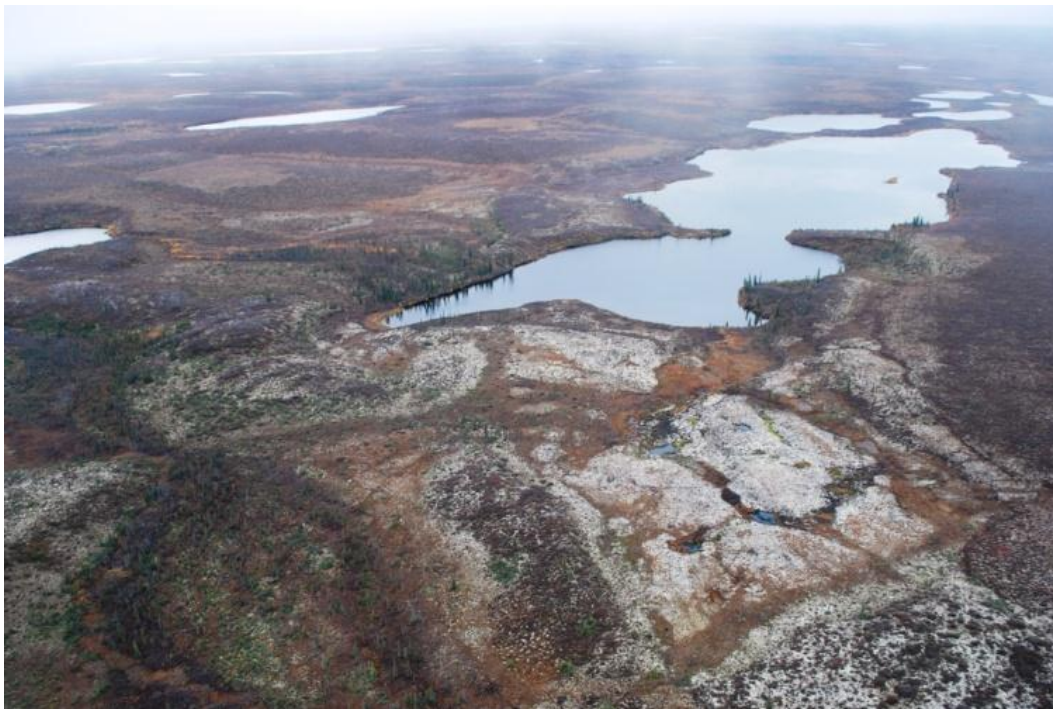
Photo A-6 Aerial oblique view of Borrow Source 2.45 (looking northwest)

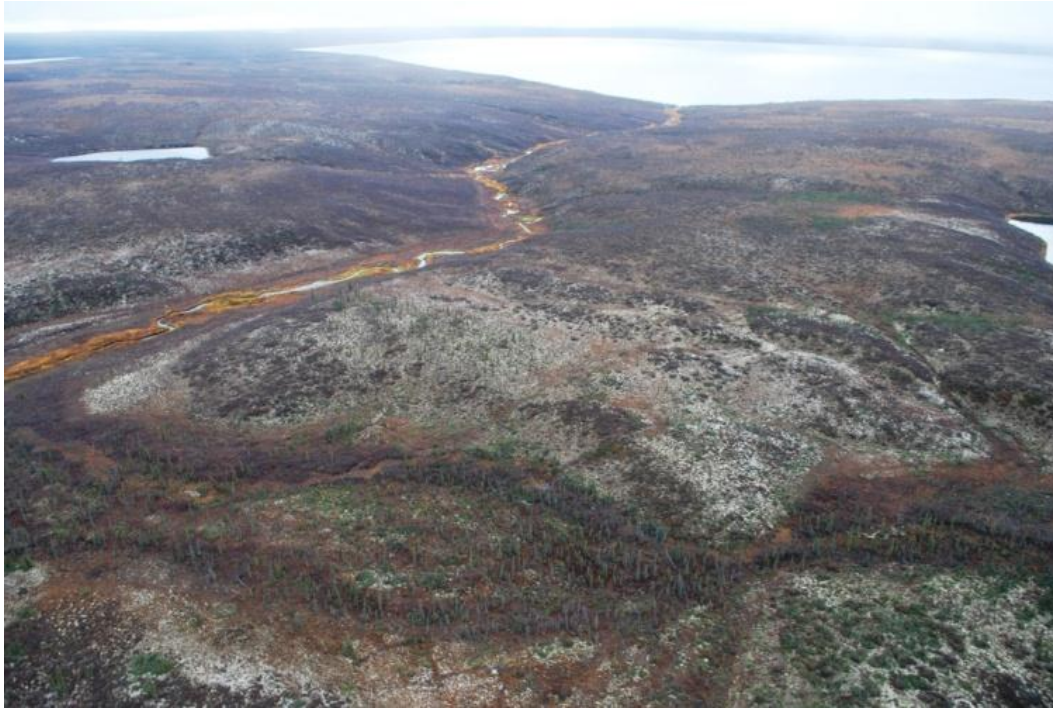
Photo A-7 Aerial oblique view of Borrow Source 2.45 (Noell Lake in the background)

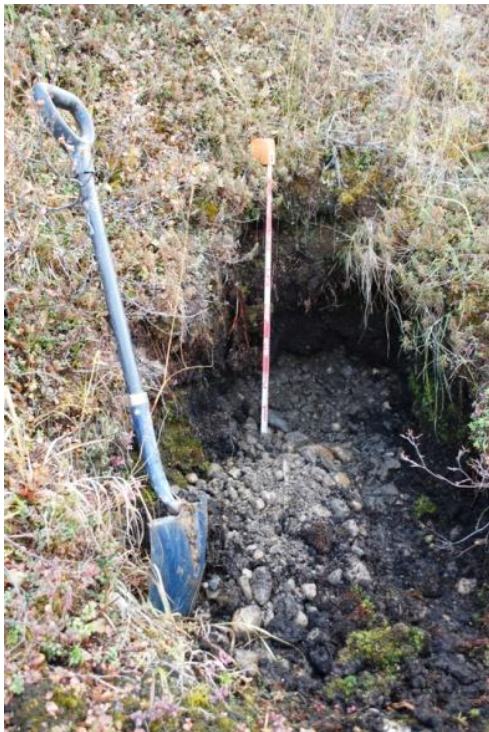
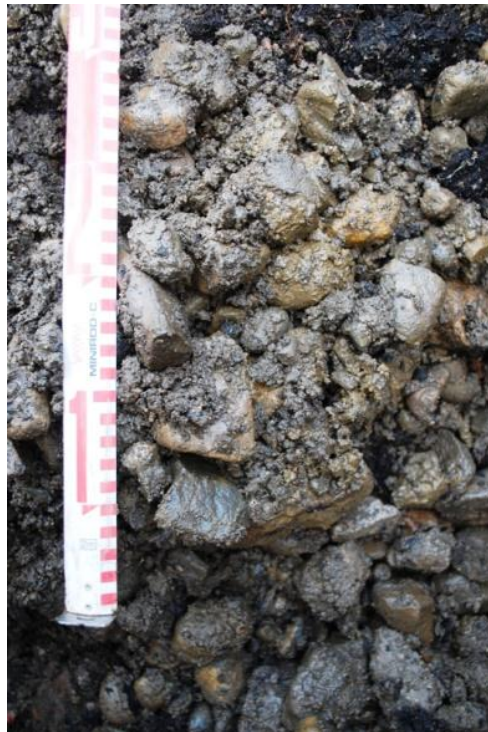
Photo A-8 Coarse-grained glaciofluvial material at Borrow Source 2.45

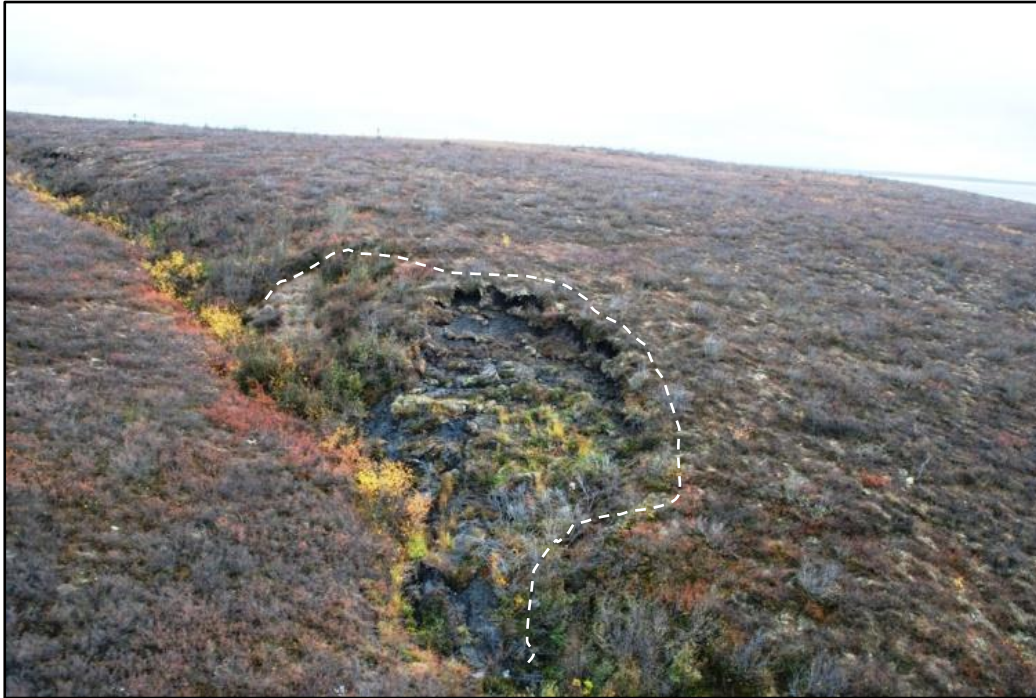
Photo A-9 Small active-layer detachment failure next to a gully at Borrow Source 2.45

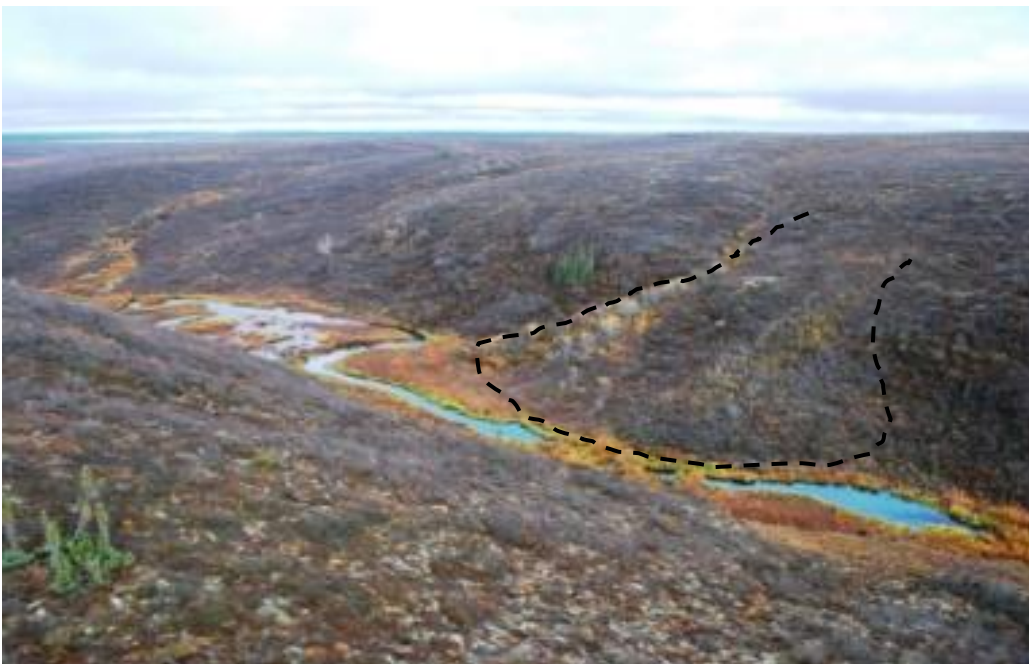
Photo A-10 Old stabilized slide (dashed line) along the eastern bank of a stream at Borrow Source 2.45 (looking northeast)

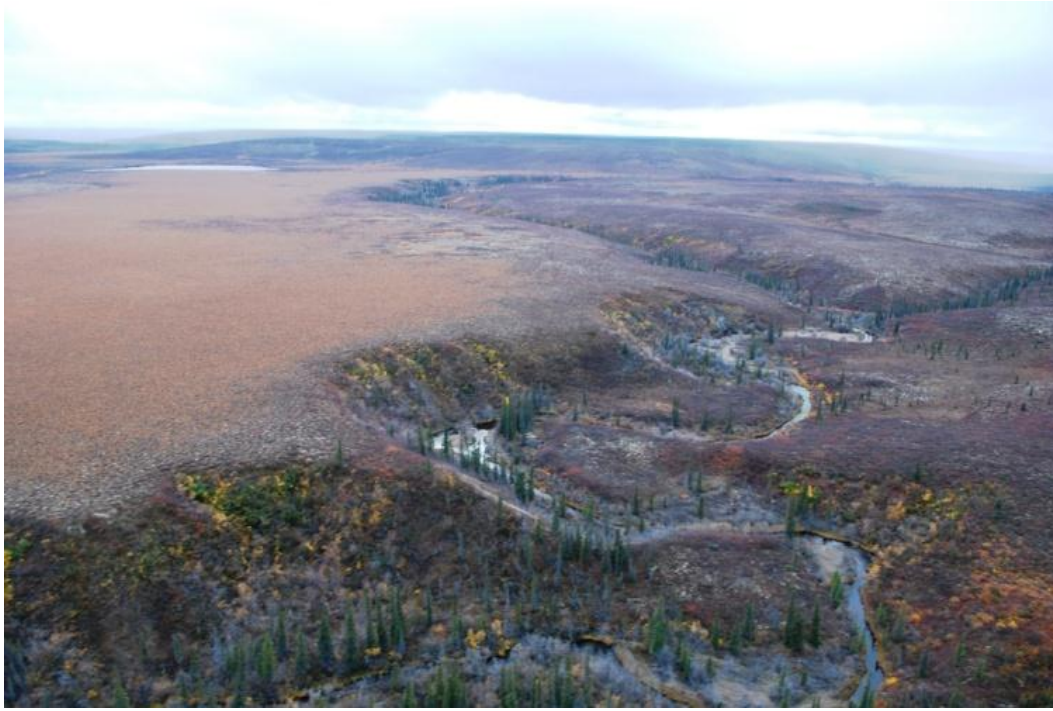
Photo A-11 Glaciofluvial terrace at Borrow Source 325 (looking west)

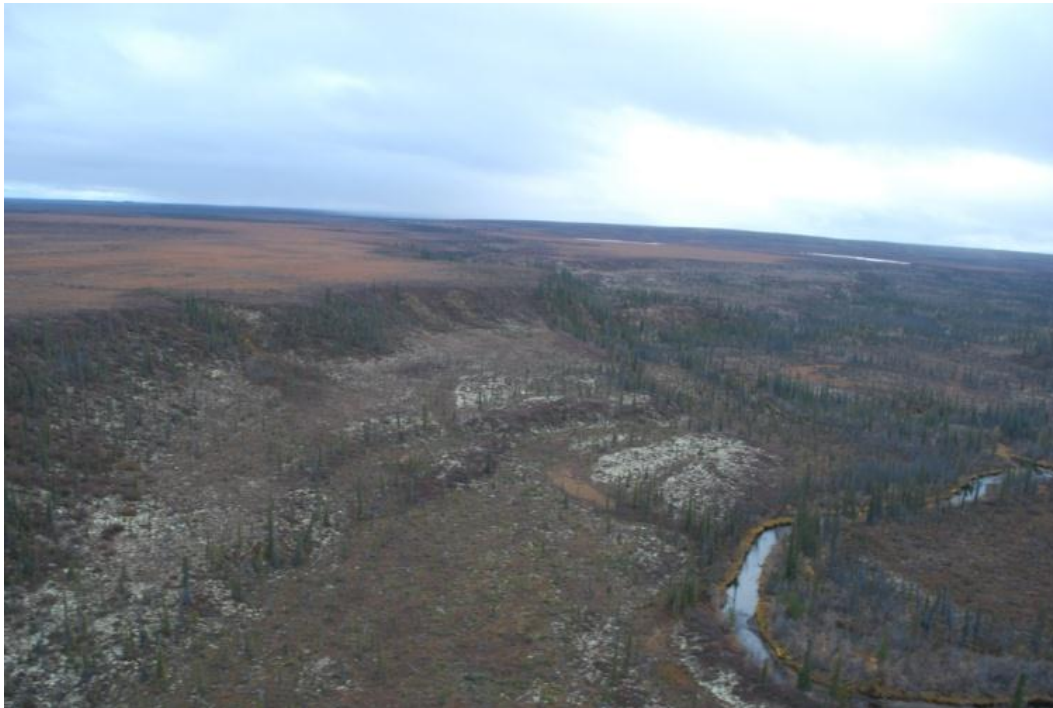
Photo A-12 Successive terraces at Borrow Source 325 (looking northwest)

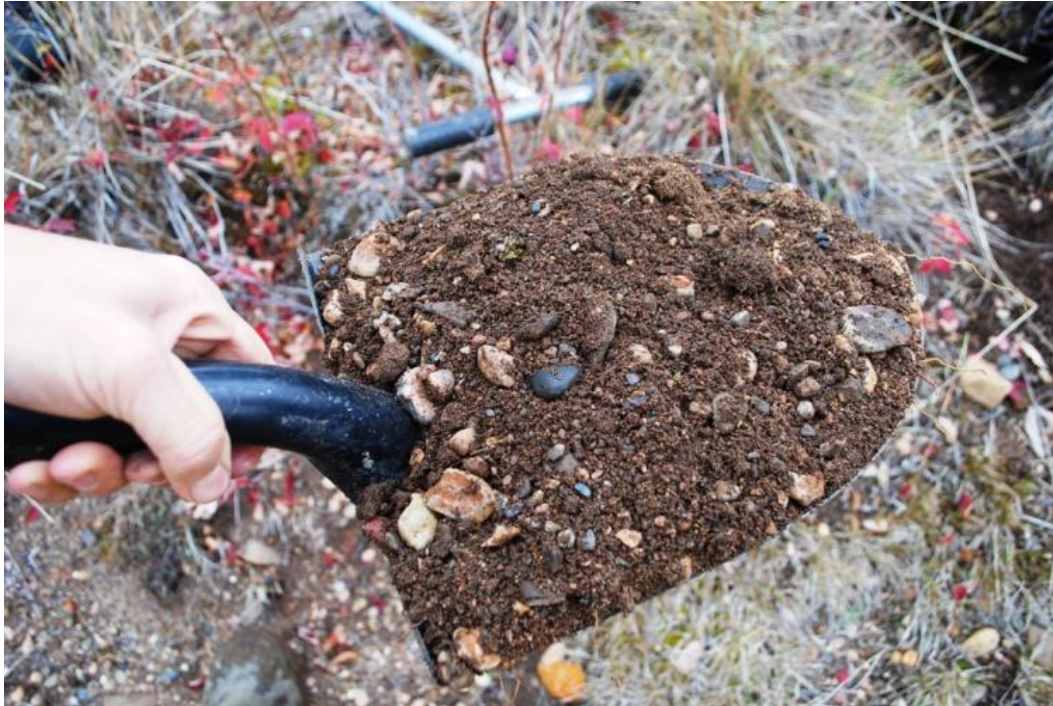
Photo A-13 Texture of glaciofluvial material at Borrow Source 325

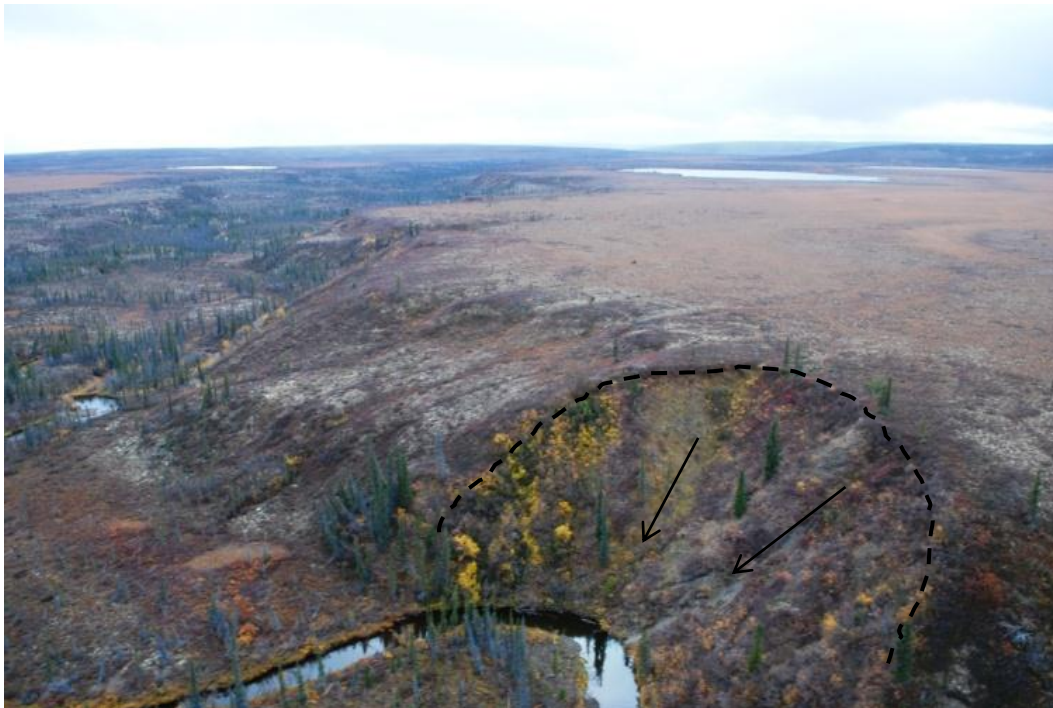
Photo A-14 Active slumping (dashed line) along the edge of a terrace at Borrow Source 325

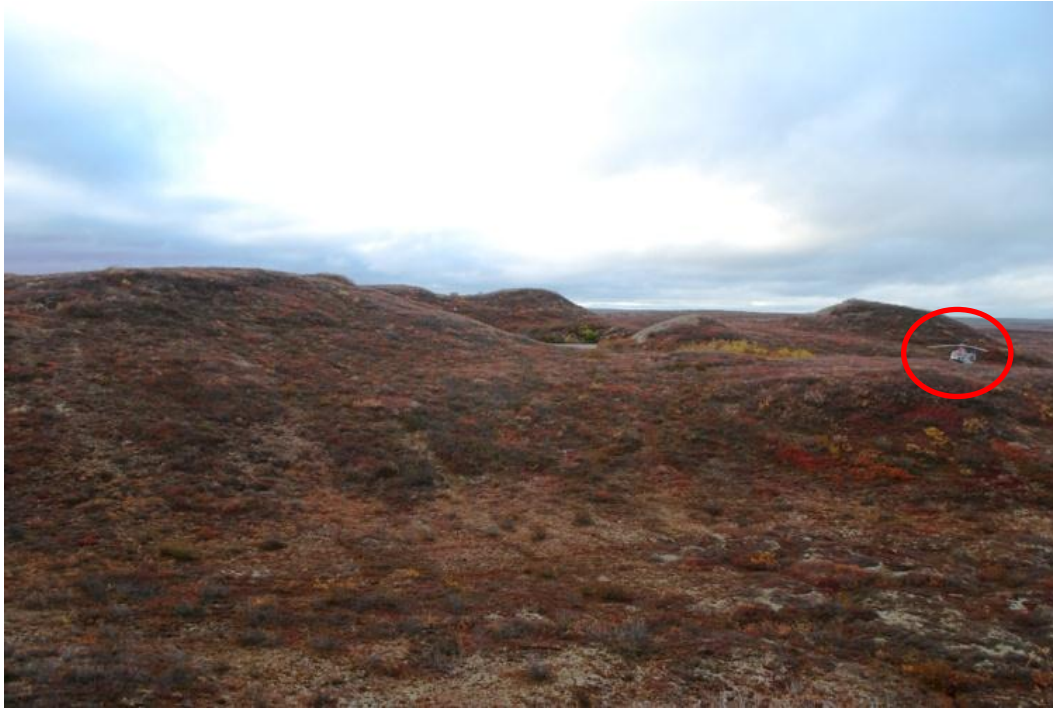
Photo A-15 Hummocky glaciofluvial deposit at Borrow Source 172 (helicopter for scale)

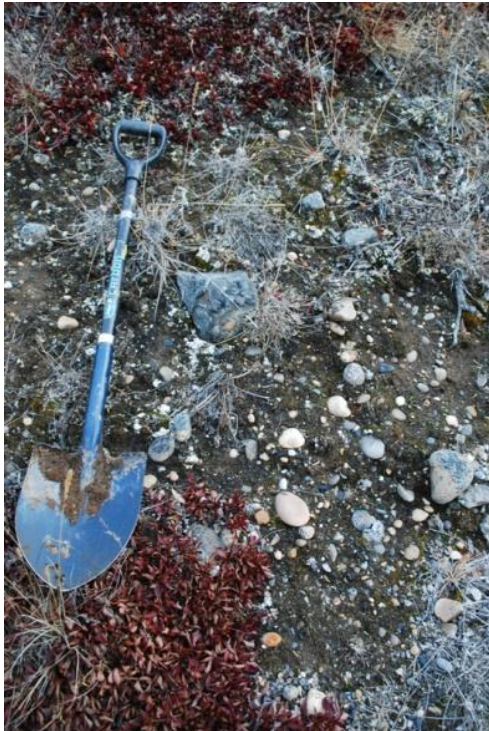
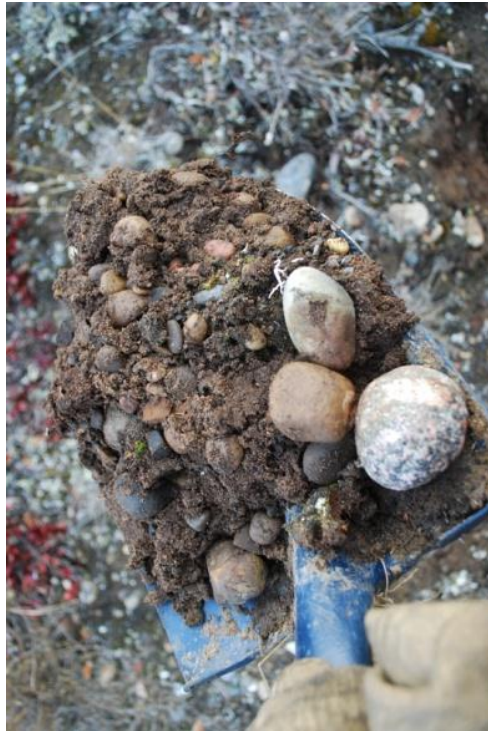
Photo A-16 Texture of glaciofluvial material at Borrow Source 172

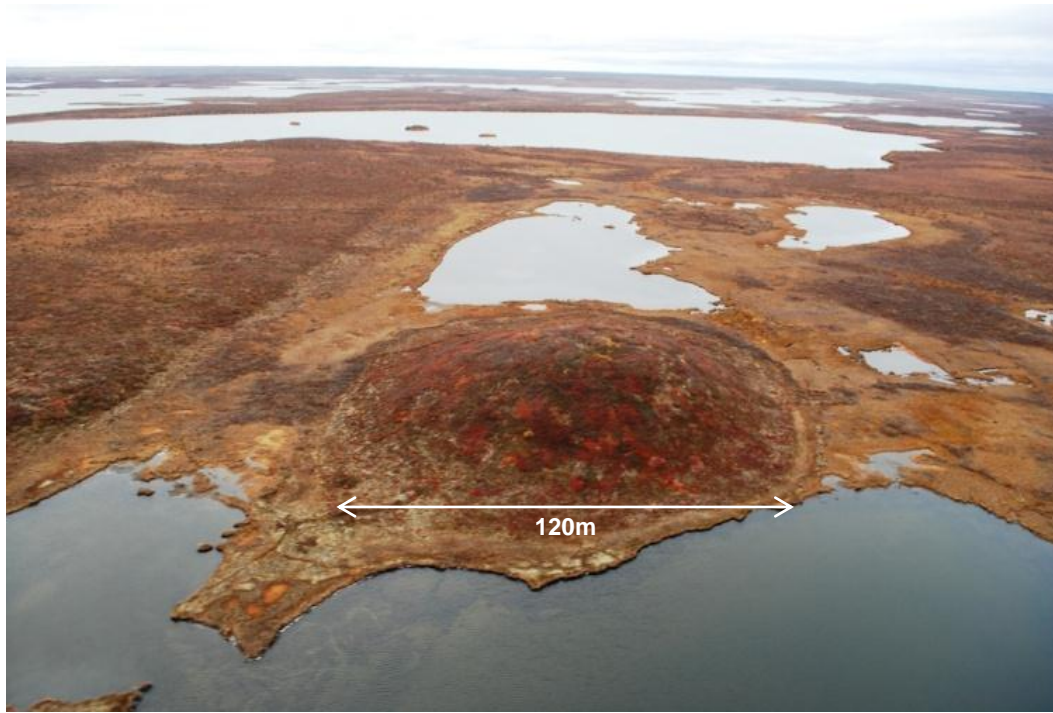
Photo A-17 Well developed pingo approximately 1km west of Alignment 1 at KP 93

A total of 16 pingos have been identified within the 1 km wide corridor of Alternative 1 and 13 pingos within the corridor of Alternative 3 (see Figure 3-4 as well as Photo A-17 and A-18). The pingos vary in size and shape. Some have the typical, well developed, conical shape while others are more subdued and have irregular shapes. A maximum pingo height of 14 m was measured using provincial DEM data. The minimum distance between the current proposed alignment and the edge of a pingo is approximately 100 m (KP 59).

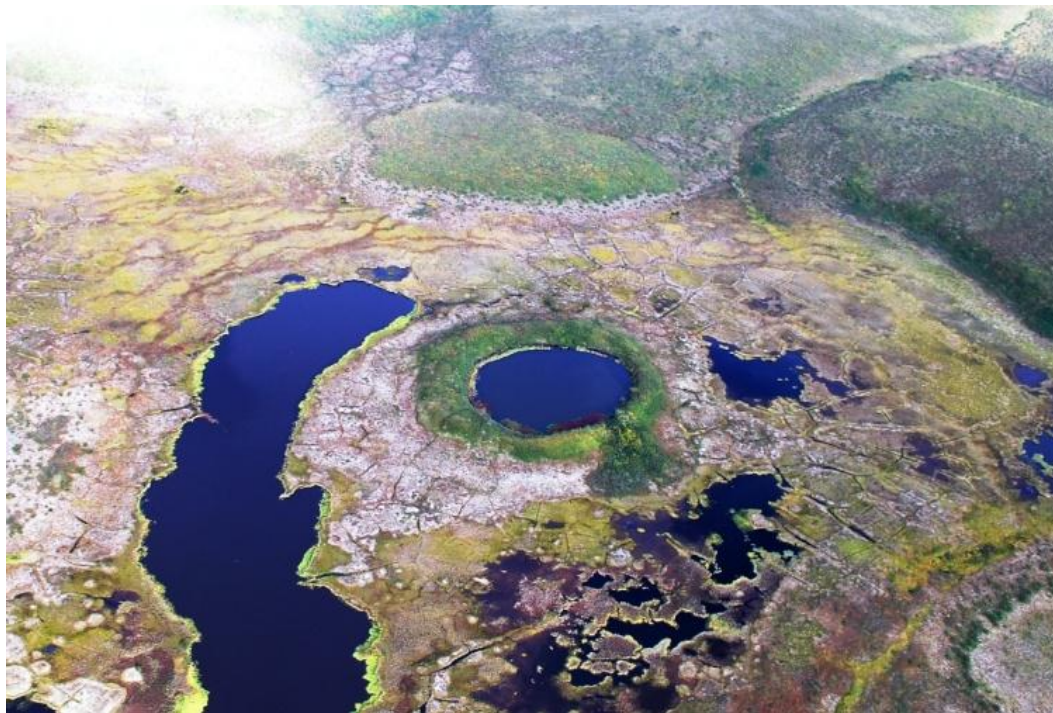
Photo A-18 Collapsed pingo
